General Information

Make	Toyota	Model	Vios
YOM	2022	Odo Meter Reading	52,377
Registration No.	FAI8913	Chassis No.	PA1B18F31M4168044
CC	1.3	Transmission	CVT
Fuel Type	Gas	Type of Body	Sedan
Colour	Red Mica Metallic

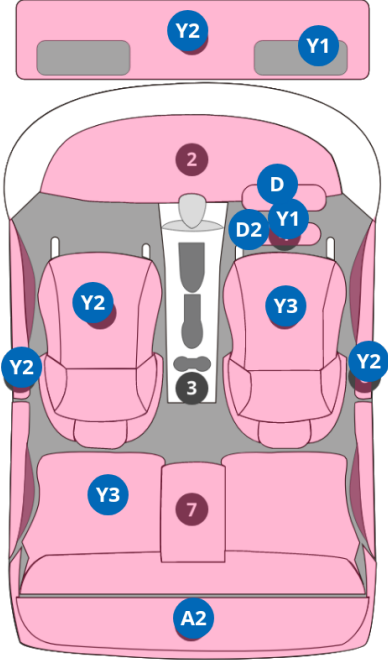
Interior Evaluation : C	Exterior Evaluation : E

<p>a : Cut, Fray d : Loose, Deformed k : Animal Hair s : Smell t : Cigarette Burns x : Defective y : Stain</p>

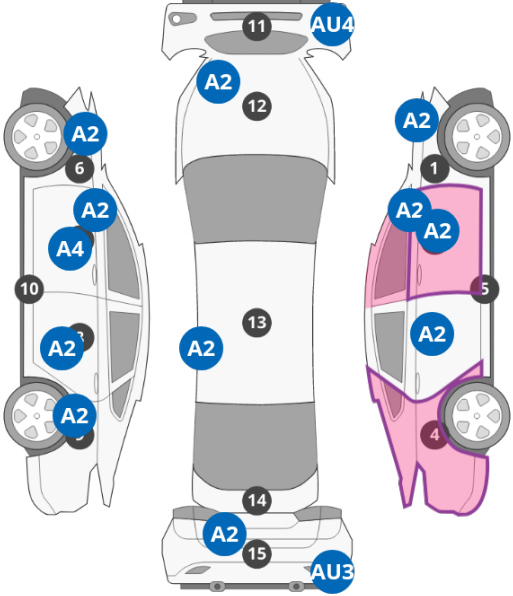
<p>A : Scratch AU : Scratch & Dent B : Modified C : Corrosion G : Stone chip P : Faded S : Rust SC : Rust & Corrosion U : Dent X : Defective Y : Crack, Gap</p>
Remarks Ceiling - Grime - Small / Sunvisor, Sunglass Holder - Grime - Minimal / (R) Front Trim - Grime - Small / (R) Front Seat - Grime - Medium / Rear Seat - Grime - Medium / (L) Front Trim - Grime - Small / (L) Front Seat - Grime - Small / (L) Front Floor Mat - Worked - Small / Mat Other - Grime - Minimal / Instrument Panel - Traces of Adhesive Tape - Yes / Trunk Room - Worn, Scratch, Cut, Crack - Small	Remarks (R) Front Door - Repair Traces - Yes / (L) Front Fender, Molding - Scratch - Small / (L) Mirror - Scratch - Small / (L) Front Door, Molding - Scratch - Large / (L) Rear Door, Molding - Scratch - Small / (L) Rear Fender, Molding - Scratch - Small / (R) Rear Fender, Molding - Repair mark - Yes / (R) Rear Door, Molding - Scratch - Small / (R) Mirror - Scratch - Small / (R) Front Door, Molding - Repair mark - Yes / (R) Front Door, Molding - Scratch - Small / (R) Front Fender, Molding - Scratch - Small / Bonnet, Headlight - Scratch - Small / Front Bumper, Grille, Lamps - Scratch & Dent - Large / Rear Bumper, Lamps, Panels - Scratch & Dent - Medium / Trunk Hood, Rear Gate - Scratch - Small / Roof - Scratch - Small
