General Information

Make	Toyota	Model	Rush
YOM	2024	Odo Meter Reading	16,104
Registration No.	FAR5411	Chassis No.	MHKE8FF3PRK059760
CC	1.5	Transmission	A/T
Fuel Type	Gas	Type of Body	SUV
Colour	Black

Body / Panel Condition

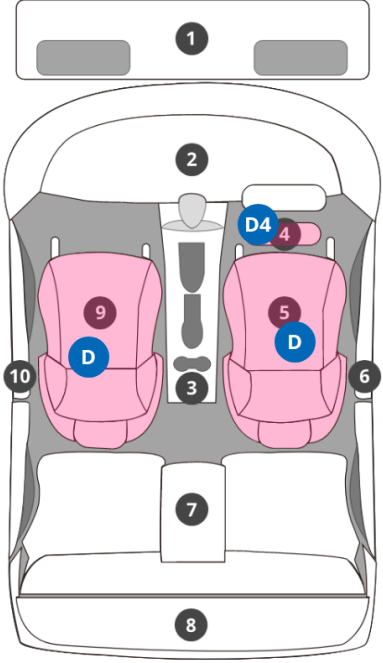
Interior Evaluation : C	Exterior Evaluation : E

<p>a : Cut, Fray d : Loose, Deformed k : Animal Hair s : Smell t : Cigarette Burns x : Defective y : Stain</p>

<p>A : Scratch AU : Scratch & Dent B : Modified C : Corrosion G : Stone chip P : Faded S : Rust SC : Rust & Corrosion U : Dent X : Defective Y : Crack, Gap</p>
<p>Remarks (L) Front Seat - Worn - Yes / (R) Front Seat - Worn - Yes / (L) Front Floor Mat - Crinkle - Large</p>	<p>Remarks Front Bumper, Grille, Lamps - Scratch & Dent - Large / (R) Front Fender, Molding - Scratch & Dent - Medium / (R) Front Door, Molding - Scratch - Medium / (R) Rear Door, Molding - Scratch - Small / (R) Rear Fender, Molding - Scratch - Small / Trunk Hood, Rear Gate - Scratch - Small / Rear Bumper, Lamps, Panels - Scratch - Medium / (L) Rear Fender, Molding - Scratch - Medium / (L) Front Fender, Molding - Dent - Medium / (L) Front Door, Molding - Dent - Small / (L) Rear Door, Molding - Scratch - Small / Bonnet, Headlight - Scratch - Small</p>
