## General Information

| Make | Toyota | Model | Vios |
| YOM | 2023 | Mileage | 32,980 |

## Body / Panel Condition

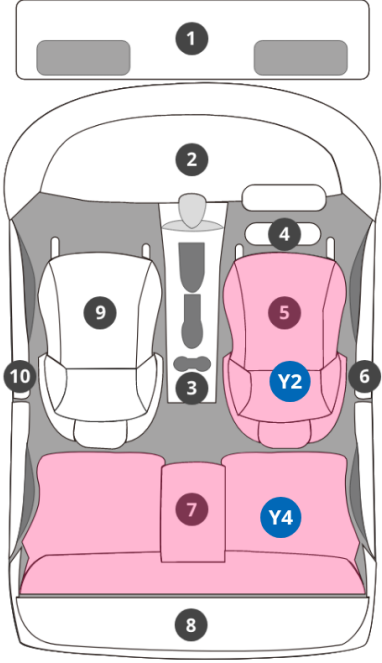
| Interior Evaluation : <b>C</b> | Exterior Evaluation : <b>B</b> |
| <p><b>Remarks</b><br/>Rear Seat - Grime - Large / (R) Front Seat - Grime - Small</p> | <p><b>Remarks</b><br/>(R) Rear Fender, Molding - Dent - Minimal / (R) Front Fender, Molding - Dent - Minimal / Front Bumper, Grille, Lamps - Scratch - Small / Trunk Hood, Rear Gate - Dent - Minimal / Roof - Dent - Small / Rear Bumper, Lamps, Panels - Dent - Small / (R) Rear Door, Molding - Dent - Minimal / (L) Rear Door, Molding - Dent - Minimal</p> |
