## General Information

| Make | Suzuki | Model | S-Presso |
| Registration No. | FAS6502 | Chassis No. | MA3FL61S2SA522966 |

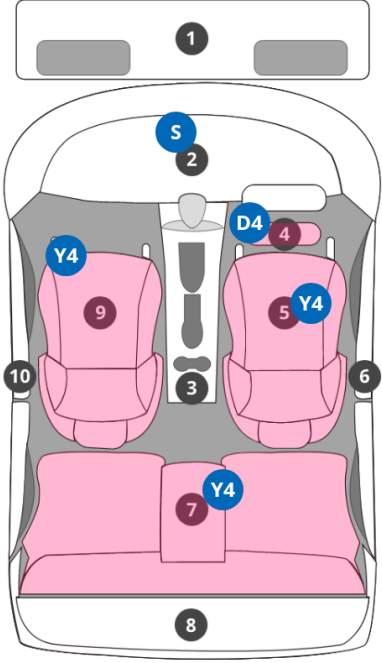
| Interior Evaluation : <span style="color: red;">C</span> | Exterior Evaluation : <span style="color: red;">C</span> |
| <p><b>Remarks</b><br/>(R) Front Seat - Grime - Large / Rear Seat - Grime - Large / (L) Front Seat - Grime - Large / (L) Front Floor Mat - Worked - Large / Overall Interior - Smell - Yes</p> | <p><b>Remarks</b><br/>(R) Front Fender, Molding - Scratch &amp; Dent - Large / Front Bumper, Grille, Lamps - Scratch - Large / Rear Bumper, Lamps, Panels - Scratch &amp; Dent - Large / (R) Rear Fender, Molding - Scratch &amp; Dent - Small / (R) Rear Door, Molding - Scratch &amp; Dent - Medium / (R) Front Door, Molding - Scratch - Small / (L) Front Fender, Molding - Scratch - Minimal / (L) Front Door, Molding - Scratch - Minimal / (L) Rear Door, Molding - Scratch - Minimal / (L) Rear Fender, Molding - Scratch - Minimal / Trunk Hood, Rear Gate - Scratch - Minimal</p> |
