General Information

Make	Suzuki	Model	S-Presso
YOM	2025	Odo Meter Reading	5,998
Registration No.	GBJ6593	Chassis No.	MA3FL61S0SA528460
CC	1.0	Transmission	A/T
Fuel Type	Gas	Type of Body	Hatchback
Colour	White

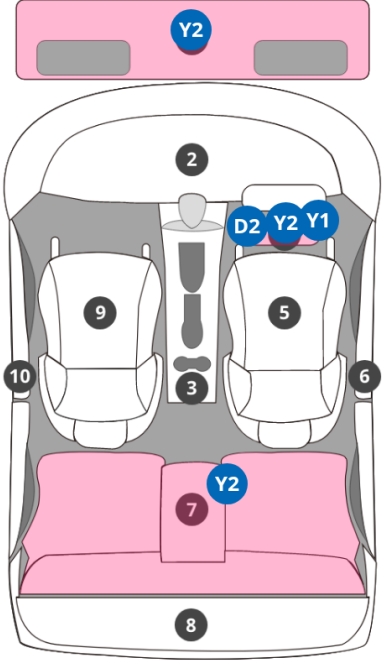
Interior Evaluation : B	Exterior Evaluation : C

<p>a : Cut, Fray d : Loose, Deformed k : Animal Hair s : Smell t : Cigarette Burns x : Defective y : Stain</p>

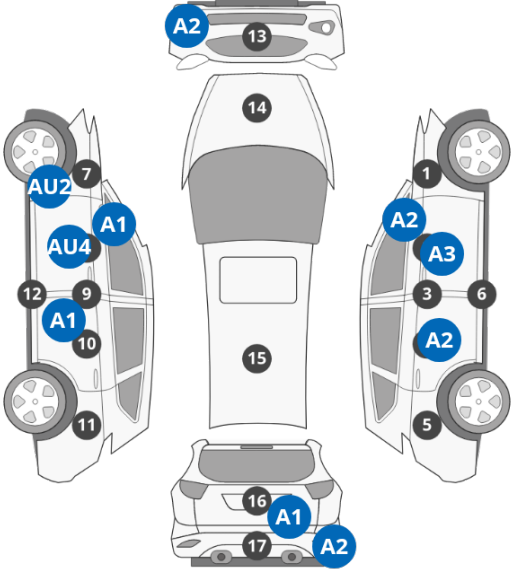
<p>A : Scratch AU : Scratch & Dent B : Modified C : Corrosion G : Stone chip P : Faded S : Rust SC : Rust & Corrosion U : Dent X : Defective Y : Crack, Gap</p>
<p>Remarks Ceiling - Grime - Small / (R) Front Floor Mat - Grime - Minimal / Mat Other - Grime - Small / Rear Seat - Grime - Small / (L) Front Floor Mat - Worked - Small</p>	<p>Remarks (R) Mirror - Scratch - Small / (R) Front Door, Molding - Scratch - Medium / (R) Rear Door, Molding - Scratch - Small / (L) Front Door, Molding - Scratch & Dent - Large / Trunk Hood, Rear Gate - Scratch - Minimal / Rear Bumper, Lamps, Panels - Scratch - Small / (L) Rear Door, Molding - Scratch - Minimal / (L) Front Fender, Molding - Scratch & Dent - Small / (L) Mirror - Scratch - Minimal / Front Bumper, Grille, Lamps - Scratch - Small</p>
