## General Information

| Make | Toyota | Model | Avanza |
| Registration No. | GBJ1400 | Chassis No. | MHFAA1BYXR0035107 |

## Body / Panel Condition

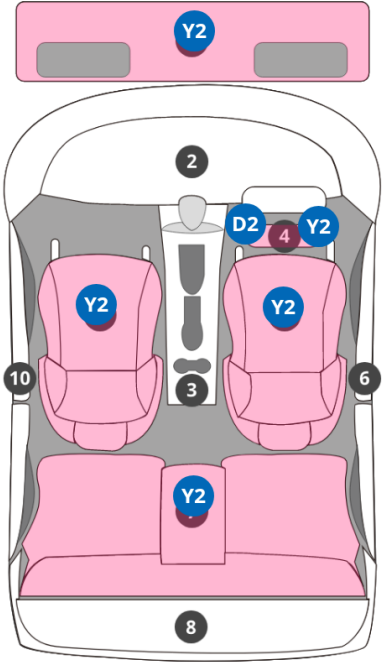
| Interior Evaluation : <b>B</b> | Exterior Evaluation : <b>E</b> |
| <p><b>Remarks</b><br/>Rear Seat - Grime - Small / Ceiling - Grime - Small / (L) Front Floor Mat - Worked - Small / (R) Front Floor Mat - Grime - Small / (R) Front Seat - Grime - Small / (L) Front Seat - Grime - Small</p> | <p><b>Remarks</b><br/>(R) Mirror - Scratch - Small / (R) Front Fender, Molding - Scratch - Medium / (R) Front Door, Molding - Scratch - Large / (R) Rear Door, Molding - Scratch - Small / (R) Rear Fender, Molding - Scratch - Small / Trunk Hood, Rear Gate - Scratch &amp; Dent - Small / Rear Bumper, Lamps, Panels - Scratch &amp; Dent - Large / (L) Rear Door, Molding - Scratch &amp; Dent - Large / (L) Rear Fender, Molding - Scratch &amp; Dent - Small / (L) Mirror - Scratch - Small / (L) Step, In-panel, Side Spoiler - Scratch - Small / (L) Front Fender, Molding - Scratch - Minimal / Front Bumper, Grille, Lamps - Scratch &amp; Dent - Large</p> |
