## General Information

| Make | Suzuki | Model | Carry |
| Registration No. | GBA7993 | Chassis No. | MHYDC61T2PJ214802 |

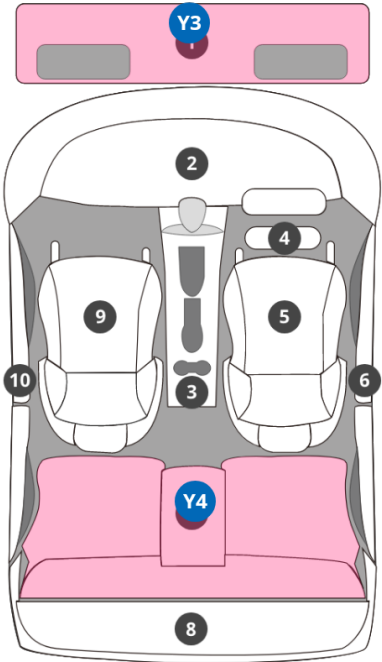
| Interior Evaluation : <span style="color: red;">C</span> | Exterior Evaluation : <span style="color: red;">D</span> |
|---|---|
| <b>Remarks</b><br>Ceiling - Grime - Medium / Rear Seat - Grime - Large | <b>Remarks</b><br>(L) Center Panel - Scratch & Dent - Medium / (L) Front Door, Molding - Scratch - Small / (R) Front Fender, Molding - Scratch - Small / Front Bumper, Grille, Lamps - Scratch - Small / (R) Mirror - Scratch - Small / (R) Front Door, Molding - Scratch - Medium / (R) Center Panel - Scratch - Small / (R) Side Gate - Scratch - Small / Rear Bumper, Lamps, Panels - Scratch & Dent - Large / Rear Gate - Scratch - Small / (L) Side Gate - Scratch - Minimal / Roof - Scratch - Small / (R) Rear Corner Panel - Scratch - Small |
