## General Information

| Make | Toyota | Model | Vios |
| Registration No. | GBE7412 | Chassis No. | PA1B18F35R4257851 |

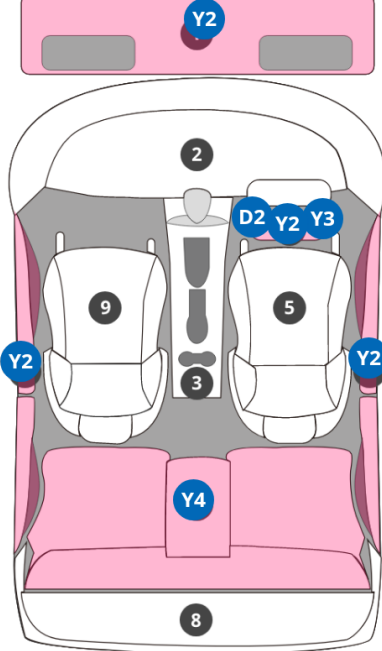
| Interior Evaluation : <span style="color: red;">C</span> | Exterior Evaluation : <span style="color: red;">E</span> |
| <p><b>Remarks</b><br/>Ceiling - Grime - Small / (R) Front Trim - Grime - Small / (R) Front Floor Mat - Grime - Medium / Rear Seat - Grime - Large / Mat Other - Grime - Small / (L) Front Trim - Grime - Small / (L) Front Floor Mat - Worked - Small</p> | <p><b>Remarks</b><br/>(L) Front Fender, Molding - Scratch - Small / (L) Front Door, Molding - Scratch - Medium / (L) Rear Door, Molding - Scratch - Large / (L) Rear Fender, Molding - Scratch - Small / Trunk Hood, Rear Gate - Scratch &amp; Dent - Small / Rear Bumper, Lamps, Panels - Scratch &amp; Dent - Large / (R) Rear Door, Molding - Scratch - Medium / (R) Rear Fender, Molding - Scratch - Small / (R) Front Door, Molding - Scratch - Large / (R) Mirror - Scratch - Small / (R) Step, In-panel, Side Spoiler - Scratch &amp; Dent - Large / (R) Front Fender, Molding - Scratch - Large / Bonnet, Headlight - Scratch - Medium / Front Bumper, Grille, Lamps - Scratch - Small / Roof - Dent - Small / (L) Mirror - Crack - Cracks</p> |

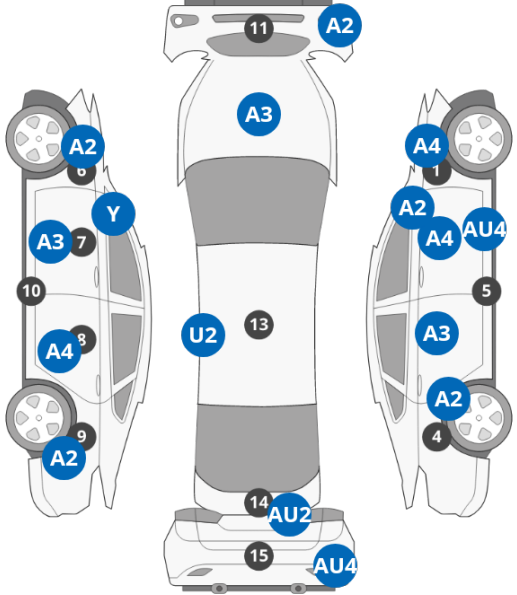
Rear left door cannot open. Left side mirror crack. unusual sound when opening front right door. Gap at front and rear bumper. Without warranty booklet, spare tire, jack and tools. With seat cover. 3 keys. With LTO plate.
