General Information

Make	Toyota	Model	Vios
YOM	2023	Odo Meter Reading	140,261
Registration No.	GAS9410	Chassis No.	PA1B18F37N4194150
CC	1.3	Transmission	CVT
Fuel Type	Gas	Type of Body	Sedan
Colour	Silver

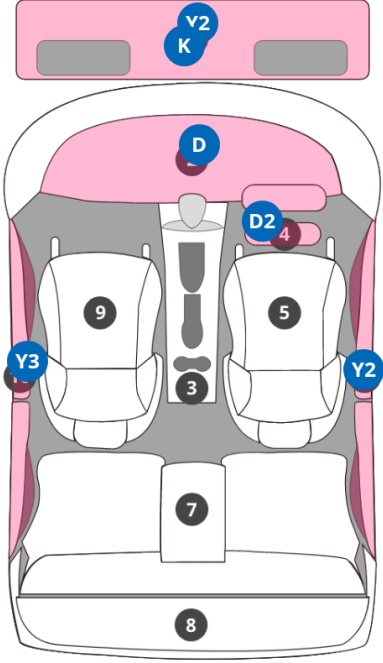
Interior Evaluation : B	Exterior Evaluation : E

<p>a : Cut, Fray d : Loose, Deformed k : Animal Hair s : Smell t : Cigarette Burns x : Defective y : Stain</p>

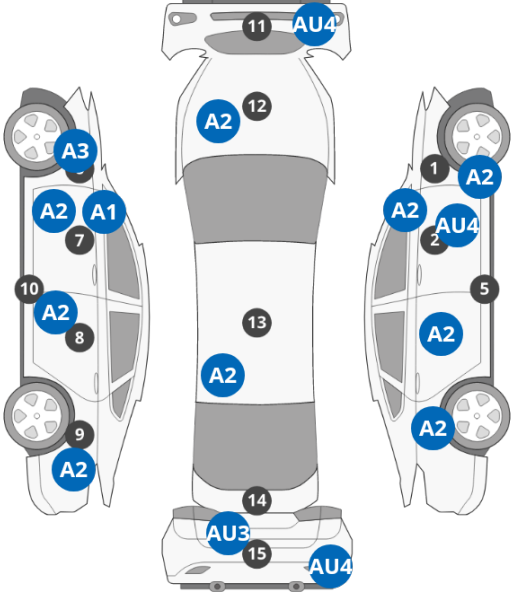
<p>A : Scratch AU : Scratch & Dent B : Modified C : Corrosion G : Stone chip P : Faded S : Rust SC : Rust & Corrosion U : Dent X : Defective Y : Crack, Gap</p>
<p>Remarks Dashboard - Traces of Adhesive Tape - Yes / Ceiling - Grime - Small / Overall Interior - Animal Hair - Yes / (R) Front Trim - Grime - Small / (L) Front Trim - Grime - Medium / (L) Front Floor Mat - Worked - Small</p>	<p>Remarks (R) Mirror - Scratch - Small / (R) Front Fender, Molding - Scratch - Small / (R) Front Door, Molding - Scratch & Dent - Large / (R) Rear Door, Molding - Scratch - Small / (R) Rear Fender, Molding - Scratch - Small / Trunk Hood, Rear Gate - Scratch & Dent - Medium / Rear Bumper, Lamps, Panels - Scratch & Dent - Large / (L) Rear Fender, Molding - Scratch - Small / (L) Rear Door, Molding - Scratch - Small / (L) Front Door, Molding - Scratch - Small / (L) Mirror - Scratch - Minimal / (L) Front Fender, Molding - Scratch - Medium / Front Bumper, Grille, Lamps - Scratch & Dent - Large / Bonnet, Headlight - Scratch - Small / Roof - Scratch - Small</p>
