General Information

| Make | Toyota | Model | Vios |
| Registration No. | GBJ9943 | Chassis No. | PA1B18F39R4279674 |

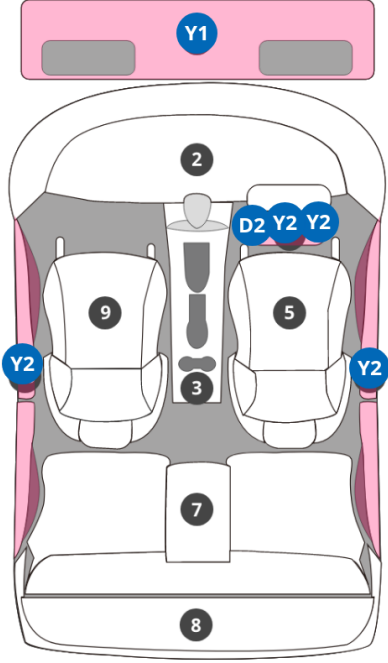
| Interior Evaluation : B | Exterior Evaluation : C |
| <p>Remarks Ceiling - Grime - Minimal / (R) Front Trim - Grime - Small / (R) Front Floor Mat - Grime - Small / Mat Other - Grime - Small / (L) Front Trim - Grime - Small / (L) Front Floor Mat - Worked - Small</p> | <p>Remarks (R) Front Fender, Molding - Scratch & Dent - Large / (R) Rear Door, Molding - Scratch - Small / (R) Front Door, Molding - Scratch - Small / (R) Rear Fender, Molding - Scratch - Small / Trunk Hood, Rear Gate - Scratch - Minimal / Rear Bumper, Lamps, Panels - Scratch - Small / (L) Rear Door, Molding - Scratch - Small / (L) Front Door, Molding - Scratch - Medium / (L) Front Fender, Molding - Scratch - Minimal / Bonnet, Headlight - Scratch - Small / Front Bumper, Grille, Lamps - Scratch - Small</p> |
