## General Information

| Make | Toyota | Model | Wigo |
| YOM | 2022 | Odo Meter Reading | 53,468 |
| Registration No. | GAV7298 | Chassis No. | MHKA4DF5FMK060669 |

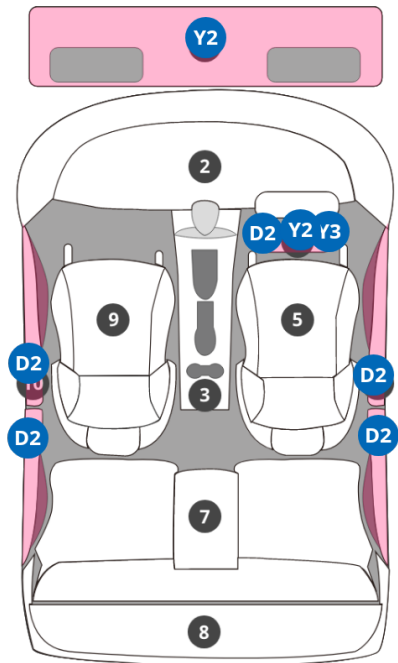
| Interior Evaluation : <b>B</b> | Exterior Evaluation : <b>E</b> |
| <p><b>Remarks</b></p> <p>Ceiling - Grime - Small / (L) Front Floor Mat - Worked - Small / (R) Front Floor Mat - Grime - Medium / (R) Front Trim - Worked - Small / (R) Rear Trim - Worked - Small / (L) Rear Trim - Worked - Small / Mat Other - Grime - Small / (L) Front Trim - Worked - Small</p> | <p><b>Remarks</b></p> <p>(R) Front Fender - Repair Traces - Yes / Bonnet - Repair Traces - Yes / (L) Rear Fender - Repair Traces - Yes / Roof - Repair Traces - Yes / (R) Mirror - Scratch - Small / (R) Front Fender, Molding - Scratch - Small / Bonnet, Headlight - Repair mark - Yes / (R) Rear Fender, Molding - Repair mark - Yes / (R) Rear Door, Molding - Repair mark - Yes / (R) Rear Door, Molding - Scratch - Small / (R) Front Door, Molding - Repair mark - Yes / (R) Front Door, Molding - Scratch - Small / Trunk Hood, Rear Gate - Scratch &amp; Dent - Medium / Rear Bumper, Lamps, Panels - Repair mark - Yes / Rear Bumper, Lamps, Panels - Scratch - Medium / (L) Rear Fender, Molding - Repair mark - Yes / (L) Rear Fender, Molding - Scratch - Small / (L) Rear Door, Molding - Scratch - Small / (L) Mirror - Scratch - Minimal / (L) Front Door, Molding - Scratch - Small / (L) Step, In-panel, Side Spoiler - Scratch - Small / (L) Front Fender, Molding - Scratch - Small / Front Bumper, Grille, Lamps - Scratch - Small / Roof - Scratch - Small</p> |
