General Information

Make	Toyota	Model	Wigo
YOM	2025	Odo Meter Reading	6,844
Registration No.	GBJ7621	Chassis No.	MHKAA1BC7SJ036947
CC	1.0	Transmission	CVT
Fuel Type	Gas	Type of Body	Hatchback
Colour	Red

Body / Panel Condition

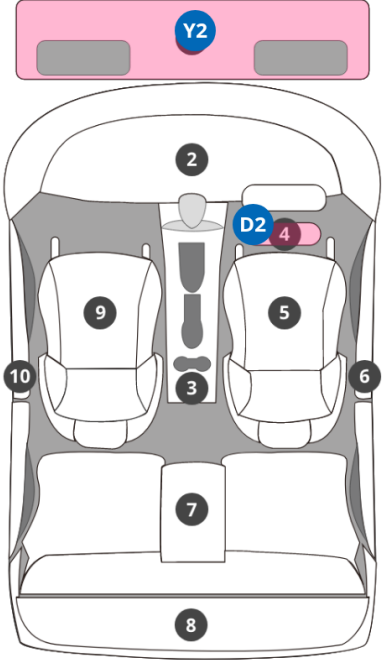
Interior Evaluation : A	Exterior Evaluation : D

<p>a : Cut, Fray d : Loose, Deformed k : Animal Hair s : Smell t : Cigarette Burns x : Defective y : Stain</p>

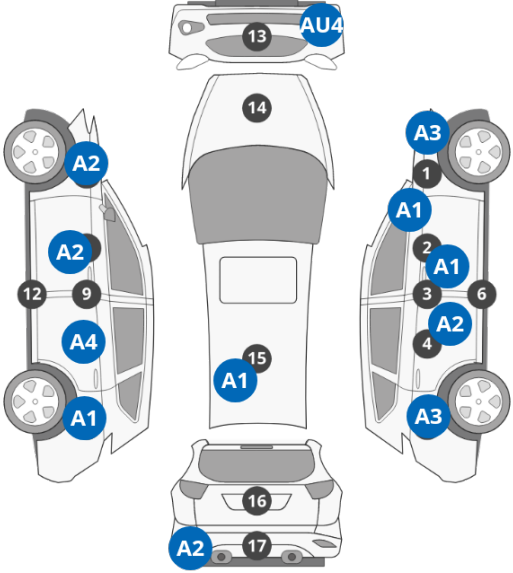
<p>A : Scratch AU : Scratch & Dent B : Modified C : Corrosion G : Stone chip P : Faded S : Rust SC : Rust & Corrosion U : Dent X : Defective Y : Crack, Gap</p>
<p>Remarks Ceiling - Grime - Small / (L) Front Floor Mat - Worked - Small</p>	<p>Remarks (R) Rear Door, Molding - Scratch - Small / (R) Front Door, Molding - Scratch - Minimal / (R) Rear Fender, Molding - Scratch - Medium / Rear Bumper, Lamps, Panels - Scratch - Small / (L) Rear Fender, Molding - Scratch - Minimal / (L) Rear Door, Molding - Scratch - Large / (L) Front Door, Molding - Scratch - Small / (L) Front Fender, Molding - Scratch - Small / Roof - Scratch - Minimal / Front Bumper, Grille, Lamps - Scratch & Dent - Large / (R) Front Fender, Molding - Scratch - Medium / (R) Mirror - Scratch - Minimal</p>
