## General Information

<b>Make</b>	Toyota	<b>Model</b>	Vios
<b>YOM</b>	2024	<b>Odo Meter Reading</b>	25,438
<b>Registration No.</b>	HAH7232	<b>Chassis No.</b>	PA1B18F38R4244415
<b>CC</b>	1.3	<b>Transmission</b>	M/T
<b>Fuel Type</b>	Gas	<b>Type of Body</b>	Sedan
<b>Colour</b>	Silver

## Body / Panel Condition

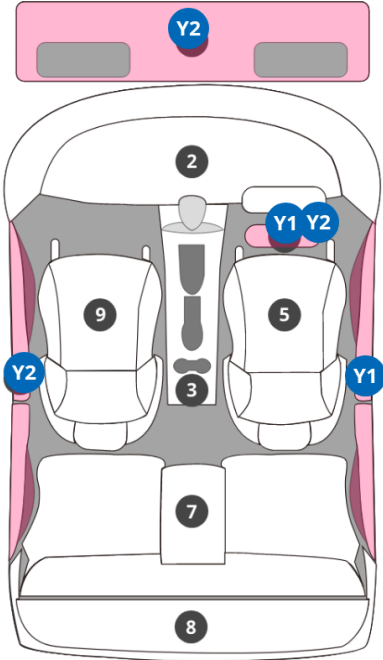
<b>Interior Evaluation :</b> <span style="float: right; color: red; font-weight: bold;">A</span>	<b>Exterior Evaluation :</b> <span style="float: right; color: red; font-weight: bold;">C</span>

<p><b>a</b> : Cut, Fray <b>d</b> : Loose, Deformed <b>k</b> : Animal Hair <b>s</b> : Smell <b>t</b> : Cigarette Burns <b>x</b> : Defective <b>y</b> : Stain</p>

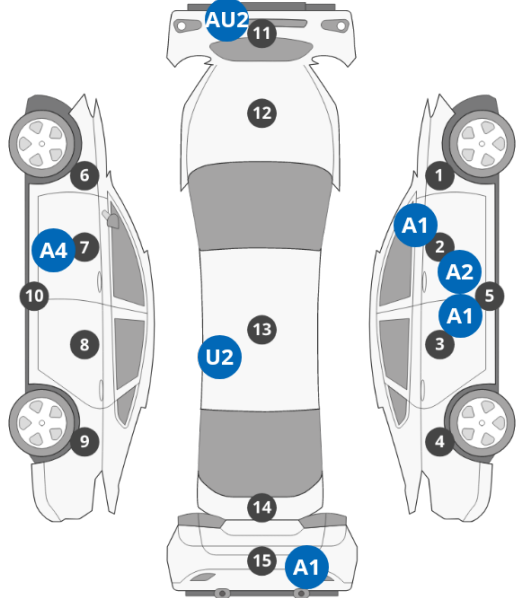
<p><b>A</b> : Scratch <b>AU</b> : Scratch &amp; Dent <b>B</b> : Modified <b>C</b> : Corrosion <b>G</b> : Stone chip <b>P</b> : Faded <b>S</b> : Rust <b>SC</b> : Rust &amp; Corrosion <b>U</b> : Dent <b>X</b> : Defective <b>Y</b> : Crack, Gap</p>
<p><b>Remarks</b> Ceiling - Grime - Small / (R) Front Floor Mat - Grime - Small / (R) Front Trim - Grime - Minimal / Mat Other - Grime - Minimal / (L) Front Trim - Grime - Small</p>	<p><b>Remarks</b> (R) Mirror - Scratch - Minimal / (R) Rear Door, Molding - Scratch - Minimal / (R) Front Door, Molding - Scratch - Small / Rear Bumper, Lamps, Panels - Scratch - Minimal / (L) Front Door, Molding - Scratch - Large / Roof - Dent - Small / Front Bumper, Grille, Lamps - Scratch &amp; Dent - Small</p>
