General Information

Make	Toyota	Model	Wigo
YOM	2023	Odo Meter Reading	35,512
Registration No.	GAP8130	Chassis No.	MHKA4DF5NJ077935
CC	1.0	Transmission	A/T
Fuel Type	Gas	Type of Body	Hatchback
Colour	Black

Body / Panel Condition

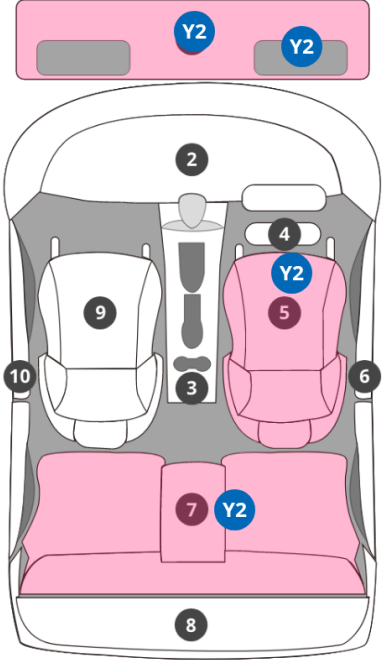
<p>a : Cut, Fray d : Loose, Deformed k : Animal Hair s : Smell t : Cigarette Burns x : Defective y : Stain</p>

<p>A : Scratch AU : Scratch & Dent B : Modified C : Corrosion G : Stone chip P : Faded S : Rust SC : Rust & Corrosion U : Dent X : Defective Y : Crack, Gap</p>
<p>Remarks Rear Seat - Grime - Small / (R) Front Seat - Grime - Small / Ceiling - Grime - Small / Sunvisor, Sunglass Holder - Grime - Small</p>	<p>Remarks (R) Front Fender, Molding - Scratch & Dent - Medium / (R) Mirror - Scratch - Small / (R) Front Door, Molding - Scratch - Medium / (R) Rear Door, Molding - Scratch - Large / (R) Center Panel - Scratch - Small / (R) Rear Fender, Molding - Scratch - Small / Trunk Hood, Rear Gate - Scratch - Small / Rear Bumper, Lamps, Panels - Scratch - Small / (L) Rear Fender, Molding - Scratch - Minimal / (L) Rear Door, Molding - Scratch - Small / (L) Front Door, Molding - Scratch - Small / (L) Mirror - Scratch - Small / (L) Front Fender, Molding - Scratch - Small / Front Bumper, Grille, Lamps - Scratch & Dent - Medium / Roof - Scratch - Small</p>

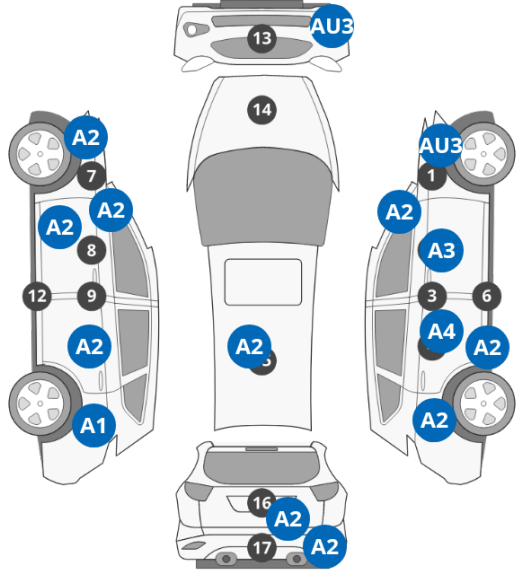
<p>Inspector Notes</p>
<p>Trunk floor missing. dent at left side mirror. With warranty booklet, spare tire, jack and tools. Incomplete seat cover. 1 key. Temporary plate.</p>
