## General Information

| Make | Toyota | Model | Wigo |
| YOM | 2021 | Odo Meter Reading | 49,996 |
| Registration No. | KAG5568 | Chassis No. | MHKA4DF5FMJ054806 |

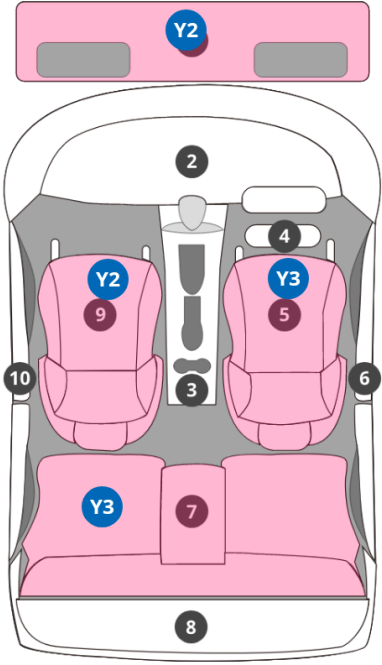
| Interior Evaluation : <b>B</b> | Exterior Evaluation : <b>D</b> |
| <p><b>Remarks</b><br/>Ceiling - Grime - Small / (R) Front Seat - Grime - Medium / Rear Seat - Grime - Medium / (L) Front Seat - Grime - Small</p> | <p><b>Remarks</b><br/>(R) Mirror - Scratch - Small / (R) Front Door, Molding - Scratch - Minimal / (R) Rear Fender, Molding - Dent - Medium / (R) Rear Door, Molding - Scratch - Small / (R) Step, In-panel, Side Spoiler - Scratch - Small / Rear Bumper, Lamps, Panels - Scratch - Medium / (L) Rear Fender, Molding - Scratch - Small / (L) Rear Door, Molding - Scratch - Small / (L) Front Door, Molding - Scratch - Small / (L) Mirror - Scratch - Small / Front Bumper, Grille, Lamps - Repair mark - Yes / (L) Front Fender, Molding - Scratch - Small / Front Bumper, Grille, Lamps - Scratch - Large / Bonnet, Headlight - Scratch - Minimal / (R) Front Fender, Molding - Scratch &amp; Dent - Minimal / Roof - Scratch - Small</p> |
