## General Information

| Make | Toyota | Model | Wigo |
| YOM | 2024 | Odo Meter Reading | 19,631 |
| Registration No. | GBD7374 | Chassis No. | MHKAA1BC8RJ024431 |

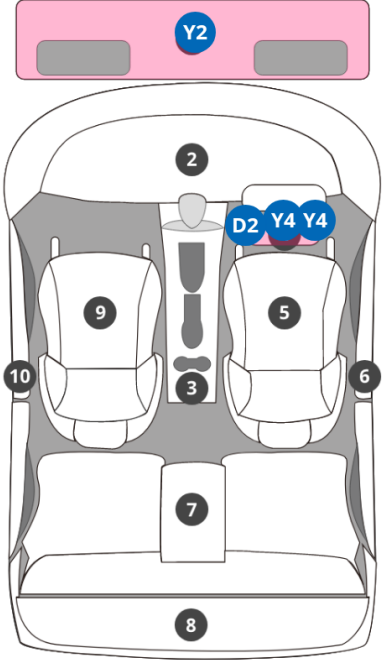
| Interior Evaluation : <span style="color: red;">C</span> | Exterior Evaluation : <span style="color: red;">D</span> |
| <p><b>Remarks</b></p> <p>Ceiling - Grime - Small / (R) Front Floor Mat - Grime - Large / Mat Other - Grime - Large / (L) Front Floor Mat - Worked - Small</p> | <p><b>Remarks</b></p> <p>Bonnet - Repair Traces - Yes / (R) Rear Fender - Repair Traces - Yes / (L) Rear Fender, Molding - Scratch - Small / (L) Front Fender, Molding - Repair mark - Yes / (R) Front Fender, Molding - Repair mark - Yes / Bonnet, Headlight - Repair mark - Yes / (L) Front Door, Molding - Scratch - Small / (L) Rear Door, Molding - Scratch - Small / Bonnet, Headlight - Scratch &amp; Dent - Minimal / Front Bumper, Grille, Lamps - Scratch &amp; Dent - Large / (R) Front Fender, Molding - Scratch - Small / (R) Mirror - Scratch - Small / (R) Rear Fender, Molding - Scratch - Small / (R) Rear Door, Molding - Scratch - Minimal / (R) Front Door, Molding - Scratch - Small / (R) Step, In-panel, Side Spoiler - Scratch - Minimal / Trunk Hood, Rear Gate - Scratch - Small / Rear Bumper, Lamps, Panels - Scratch - Small</p> |

| Inspector Notes |
|---|
| <p>Carpet and mattings has molds. Without warranty booklet and tools. With spare tire, jack and seat cover. 1 key. No LTO plate.</p> |
