## General Information

<b>Make</b>	Toyota	<b>Model</b>	Wigo
<b>YOM</b>	2025	<b>Odo Meter Reading</b>	6,017
<b>Registration No.</b>	HAH5567	<b>Chassis No.</b>	MHKAA1BC4RJ828041
<b>CC</b>	1.0	<b>Transmission</b>	CVT
<b>Fuel Type</b>	Gas	<b>Type of Body</b>	Hatchback
<b>Colour</b>	Red

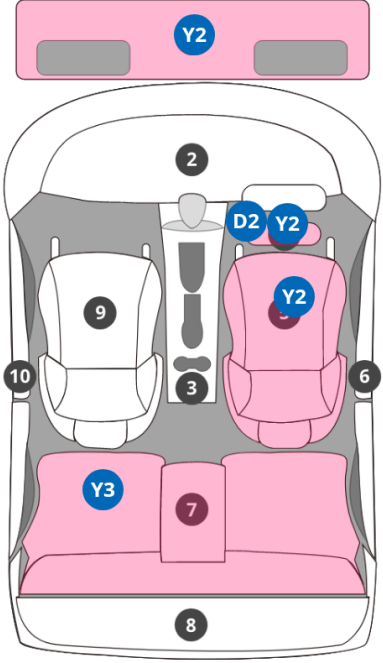
<b>Interior Evaluation :</b> <span style="float: right; color: red; font-weight: bold;">B</span>	<b>Exterior Evaluation :</b> <span style="float: right; color: red; font-weight: bold;">E</span>

<p><b>a</b> : Cut, Fray <b>d</b> : Loose, Deformed <b>k</b> : Animal Hair <b>s</b> : Smell <b>t</b> : Cigarette Burns <b>x</b> : Defective <b>y</b> : Stain</p>

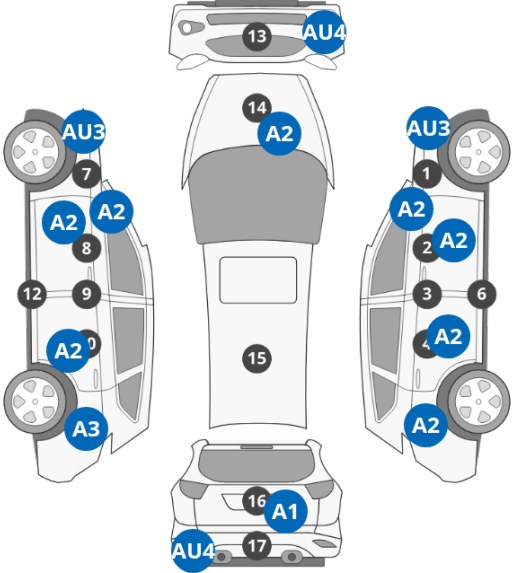
<p><b>A</b> : Scratch <b>AU</b> : Scratch &amp; Dent <b>B</b> : Modified <b>C</b> : Corrosion <b>G</b> : Stone chip <b>P</b> : Faded <b>S</b> : Rust <b>SC</b> : Rust &amp; Corrosion <b>U</b> : Dent <b>X</b> : Defective <b>Y</b> : Crack, Gap</p>
<p><b>Remarks</b> Ceiling - Grime - Small / Mat Other - Grime - Small / (L) Front Floor Mat - Worked - Small / Rear Seat - Grime - Medium / (R) Front Seat - Grime - Small</p>	<p><b>Remarks</b> Front Bumper, Grille, Lamps - Scratch &amp; Dent - Large / (R) Front Fender, Molding - Scratch &amp; Dent - Medium / (R) Mirror - Scratch - Small / (R) Front Door, Molding - Scratch - Small / (R) Rear Door, Molding - Scratch - Small / (R) Rear Fender, Molding - Scratch - Small / Trunk Hood, Rear Gate - Scratch - Minimal / Rear Bumper, Lamps, Panels - Scratch &amp; Dent - Large / (L) Rear Fender, Molding - Scratch - Medium / (L) Rear Door, Molding - Scratch - Small / (L) Front Door, Molding - Scratch - Small / (L) Mirror - Scratch - Small / (L) Front Fender, Molding - Scratch &amp; Dent - Medium / Bonnet, Headlight - Scratch - Small</p>
