General Information

Make	Toyota	Model	Vios
YOM	2024	Odo Meter Reading	16,155
Registration No.	NHQ6434	Chassis No.	PA1B18F36R4252304
CC	1.3	Transmission	CVT
Fuel Type	Gas	Type of Body	Sedan
Colour	Red

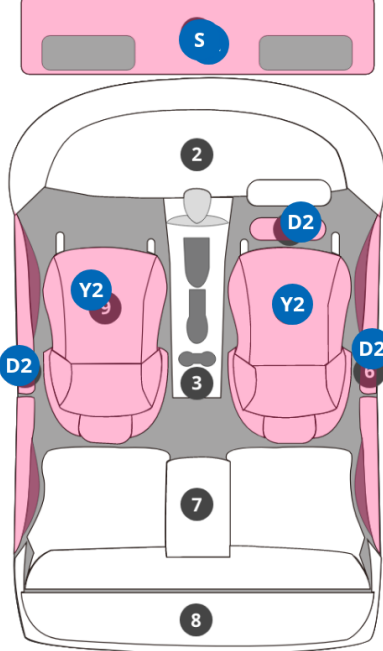
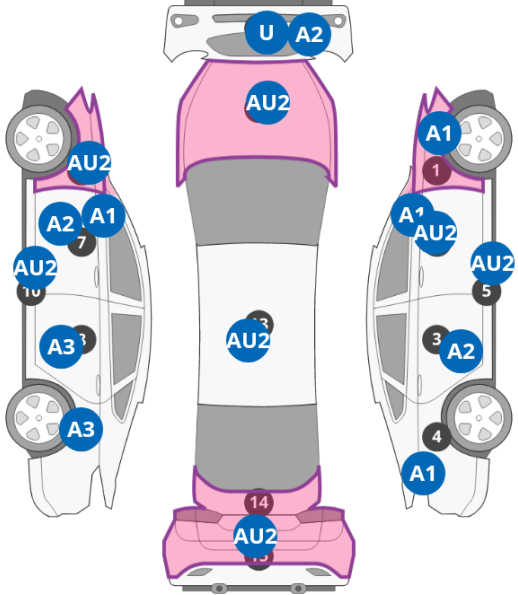
Interior Evaluation :	B	Exterior Evaluation :	E

<p>a : Cut, Fray d : Loose, Deformed k : Animal Hair s : Smell t : Cigarette Burns x : Defective y : Stain</p>		<p>A : Scratch AU : Scratch & Dent B : Modified C : Corrosion G : Stone chip P : Faded S : Rust SC : Rust & Corrosion U : Dent X : Defective Y : Crack, Gap</p>	
<p>Remarks (L) Front Floor Mat - Worked - Small / (L) Front Trim - Worked - Small / (R) Front Trim - Worked - Small / Ceiling - Grime - Small / Overall Interior - Animal Hair - Yes / Overall Interior - Smell - Yes / (R) Front Seat - Grime - Small / (L) Front Seat - Grime - Small</p>		<p>Remarks Trunk Hood, Rear Gate - Repair Traces - Yes / (L) Front Fender, Molding - Repair mark - Yes / (R) Front Fender, Molding - Repair mark - Yes / Bonnet, Headlight - Repair mark - Yes / Trunk Hood, Rear Gate - Repair mark - Yes / Member (Bolted) - Dent - Yes / Bonnet, Headlight - Scratch & Dent - Small / (R) Mirror - Scratch - Minimal / (R) Front Fender, Molding - Scratch - Minimal / (R) Front Door, Molding - Scratch & Dent - Small / (R) Rear Door, Molding - Scratch - Small / (R) Step, In-panel, Side Spoiler - Scratch & Dent - Small / (R) Rear Fender, Molding - Scratch - Minimal / Front Bumper, Grille, Lamps - Scratch - Small / Trunk Hood, Rear Gate - Scratch & Dent - Small / Roof - Scratch & Dent - Small / (L) Front Door, Molding - Scratch - Small / (L) Step, In-panel, Side Spoiler - Scratch & Dent - Small / (L) Front Fender, Molding - Scratch & Dent - Small / (L) Mirror - Scratch - Minimal / (L) Rear Door, Molding - Scratch - Medium / (L) Rear Fender, Molding - Scratch - Medium</p>

Frame Evaluation :	C	Functional Evaluation :	A
<p>Remarks Front Cross Member Support - Condition of Welding ? - Yes / Right Front Inside Panel (Front Side) - Traces of Bending, or Marks of Panel Repair ? - Yes / Left Front Inside Panel (Front Side) - Traces of Bending, or Marks of Panel Repair ? - Yes</p>		<p>Remarks Spare Key - Issue - Unexist</p>
