## General Information

<b>Make</b>	Toyota	<b>Model</b>	Vios
<b>YOM</b>	2024	<b>Odo Meter Reading</b>	10,084
<b>Registration No.</b>	NHM6227	<b>Chassis No.</b>	PA1B18F3XR4243220
<b>CC</b>	1.3	<b>Transmission</b>	CVT
<b>Fuel Type</b>	Gas	<b>Type of Body</b>	Sedan
<b>Colour</b>	Blue

## Body / Panel Condition

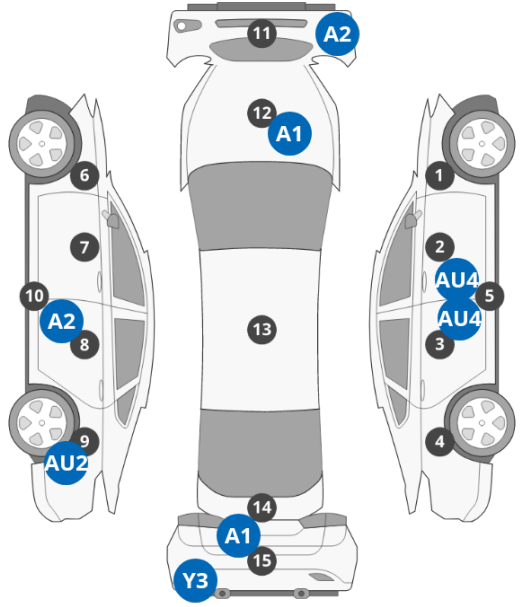
<p><b>A</b> : Scratch <b>AU</b> : Scratch &amp; Dent <b>B</b> : Modified <b>C</b> : Corrosion <b>G</b> : Stone chip <b>P</b> : Faded <b>S</b> : Rust <b>SC</b> : Rust &amp; Corrosion <b>U</b> : Dent <b>X</b> : Defective <b>Y</b> : Crack, Gap</p>
<b>Remarks</b> Defects not found	<b>Remarks</b> (R) Front Door, Molding - Scratch & Dent - Large / (R) Rear Door, Molding - Scratch & Dent - Large / Rear Bumper, Lamps, Panels - Crack, Gap - Medium / (L) Rear Fender, Molding - Scratch & Dent - Small / (L) Rear Door, Molding - Scratch - Small / Trunk Hood, Rear Gate - Scratch - Minimal / Front Bumper, Grille, Lamps - Scratch - Small / Bonnet, Headlight - Scratch - Minimal

<b>Inspector Notes</b>
With Lto plate, with warranty booklet, with spare tire, 1key, no jack and tools, scratches on headlight, plate light issue
