General Information

Make	Toyota	Model	Innova
YOM	2022	Odo Meter Reading	83,830
Registration No.	NFK9555	Chassis No.	PA2JA8EM7N0105301
CC	2.8	Transmission	A/T
Fuel Type	Diesel	Type of Body	Wagon
Colour	Blackish Red Mica

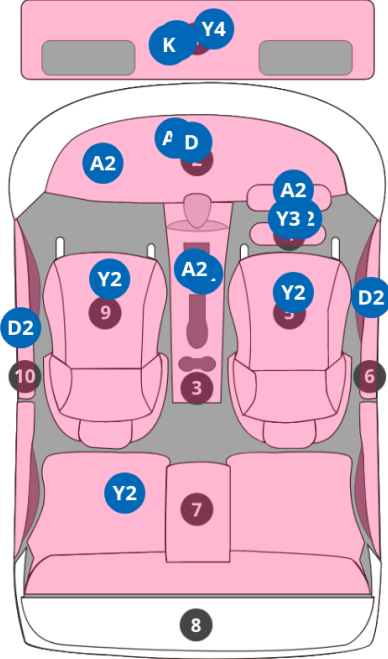
Interior Evaluation : D	Exterior Evaluation : E

<p>a : Cut, Fray d : Loose, Deformed k : Animal Hair s : Smell t : Cigarette Burns x : Defective y : Stain</p>

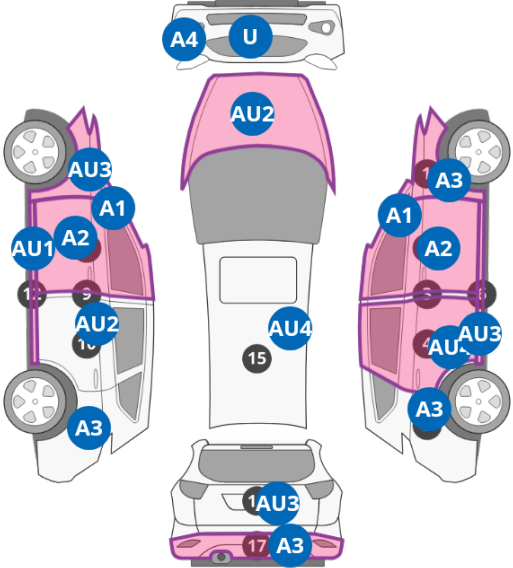
<p>A : Scratch AU : Scratch & Dent B : Modified C : Corrosion G : Stone chip P : Faded S : Rust SC : Rust & Corrosion U : Dent X : Defective Y : Crack, Gap</p>
<p>Remarks (L) Front Floor Mat - Worked - Small / Mat Other - Grime - Medium / Ceiling - Grime - Large / Overall Interior - Smell - Yes / Overall Interior - Animal Hair - Yes / Dashboard - Worn, Scratch, Cut, Crack - Small / Dashboard - Traces of Adhesive Tape - Yes / Steering Wheel - Worn, Peel, Crack - Small / Glove Box - Worn, Scratch, Cut, Crack - Small / (L) Front Seat - Grime - Small / (R) Front Seat - Grime - Small / (L) Front Trim - Worked - Small / (R) Front Trim - Worked - Small / Knobs - Worn, Peel, Crack - Small / Console, Switches, Vents - Worn, Scratch, Cut, Crack - Small / Rear Seat - Grime - Small</p>	<p>Remarks (R) Front Door - Repair Traces - Yes / (R) Front Fender - Repair Traces - Yes / Bonnet - Repair Traces - Yes / (L) Front Fender - Repair Traces - Yes / (L) Front Door - Repair Traces - Yes / Trunk Hood, Rear Gate - Repair Traces - Yes / (R) Rear Door - Repair Traces - Yes / Member (Bolted) - Dent - Yes / (L) Front Fender, Molding - Repair mark - Yes / Bonnet, Headlight - Repair mark - Yes / (R) Front Fender, Molding - Repair mark - Yes / (L) Front Door, Molding - Repair mark - Yes / (R) Front Door, Molding - Repair mark - Yes / (R) Rear Door, Molding - Repair mark - Yes / Rear Bumper, Lamps, Panels - Repair mark - Yes / (L) Step, In-panel, Side Spoiler - Repair mark - Yes / (R) Step, In-panel, Side Spoiler - Repair mark - Yes / Front Bumper, Grille, Lamps - Scratch - Large / Bonnet, Headlight - Scratch & Dent - Small / (L) Front Fender, Molding - Scratch & Dent - Medium / (L) Step, In-panel, Side Spoiler - Scratch & Dent - Minimal / (L) Front Door, Molding - Scratch - Small / (L) Rear Door, Molding - Scratch & Dent - Small / (L) Rear Fender, Molding - Scratch - Medium / Trunk Hood, Rear Gate - Scratch & Dent - Medium / Rear Bumper, Lamps, Panels - Scratch - Medium / (R) Rear Fender, Molding - Scratch - Medium / (R) Rear Door, Molding - Scratch & Dent - Large / (R) Step, In-panel, Side Spoiler - Scratch & Dent - Medium / (R) Front Door, Molding - Scratch - Small / (R) Front Fender, Molding - Scratch - Medium / (R) Mirror - Scratch - Minimal / (L) Mirror - Scratch - Minimal / Roof - Scratch & Dent - Large</p>
