General Information

Make	Toyota	Model	Vios
YOM	2024	Odo Meter Reading	26,429
Registration No.	BAG3957	Chassis No.	PA1B18F30R4258941
CC	1.3	Transmission	CVT
Fuel Type	Gas	Type of Body	Sedan
Colour	Black

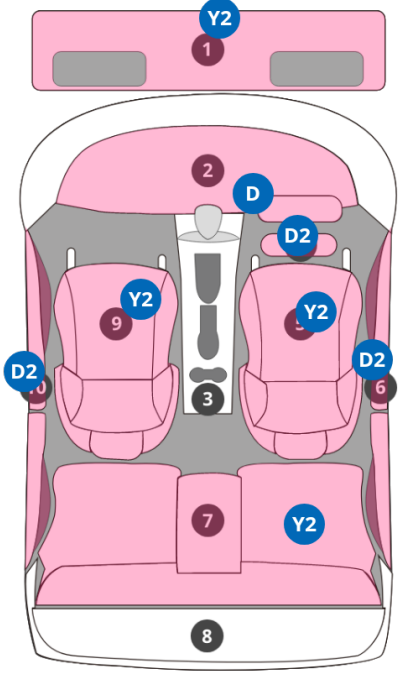
Interior Evaluation : B	Exterior Evaluation : D

<p>a : Cut, Fray d : Loose, Deformed k : Animal Hair s : Smell t : Cigarette Burns x : Defective y : Stain</p>

<p>A : Scratch AU : Scratch & Dent B : Modified C : Corrosion G : Stone chip P : Faded S : Rust SC : Rust & Corrosion U : Dent X : Defective Y : Crack, Gap</p>
<p>Remarks Rear Seat - Grime - Small / (R) Front Seat - Grime - Small / (L) Front Seat - Grime - Small / (L) Front Floor Mat - Worked - Small / (L) Front Trim - Worked - Small / (R) Front Trim - Worked - Small / Dashboard - Traces of Adhesive Tape - Yes / Ceiling - Grime - Small</p>	<p>Remarks (R) Front Fender - Repair Traces - Yes / Bonnet - Repair Traces - Yes / (L) Front Fender - Repair Traces - Yes / (R) Front Fender, Molding - Repair mark - Yes / Bonnet, Headlight - Repair mark - Yes / (L) Front Fender, Molding - Repair mark - Yes / Member (Bolted) - Dent - Yes / Front Bumper, Grille, Lamps - Scratch - Medium / (R) Front Fender, Molding - Scratch - Minimal / (R) Front Door, Molding - Scratch & Dent - Small / (R) Step, In-panel, Side Spoiler - Scratch & Dent - Small / (R) Rear Door, Molding - Scratch - Small / (R) Rear Fender, Molding - Scratch - Minimal / Rear Bumper, Lamps, Panels - Scratch - Medium / Trunk Hood, Rear Gate - Scratch & Dent - Small / (L) Rear Fender, Molding - Scratch & Dent - Minimal / (L) Rear Door, Molding - Scratch - Small / (L) Front Door, Molding - Scratch & Dent - Small / (L) Front Fender, Molding - Scratch - Minimal / (L) Mirror - Scratch - Minimal / (R) Mirror - Scratch - Minimal / Roof - Scratch & Dent - Small / Bonnet, Headlight - Scratch & Dent - Small</p>
