General Information

Make	Toyota	Model	Wigo
YOM	2025	Odo Meter Reading	13,464
Registration No.	CCP2908	Chassis No.	MHKAA1BC4SJ038302
CC	1.0	Transmission	CVT
Fuel Type	Gas	Type of Body	Hatchback
Colour	Gray

Body / Panel Condition

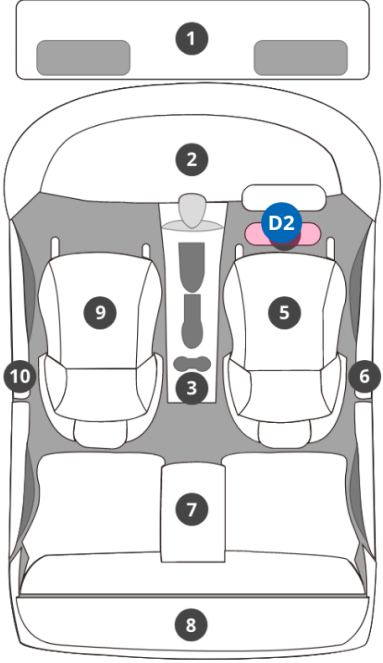
Interior Evaluation : A	Exterior Evaluation : C

<p>A : Scratch AU : Scratch & Dent B : Modified C : Corrosion G : Stone chip P : Faded S : Rust SC : Rust & Corrosion U : Dent X : Defective Y : Crack, Gap</p>
<p>Remarks (L) Front Floor Mat - Worked - Small</p>	<p>Remarks Front Bumper, Grille, Lamps - Scratch - Medium / (R) Front Door, Molding - Scratch - Small / (R) Step, In-panel, Side Spoiler - Scratch - Minimal / (R) Rear Fender, Molding - Scratch - Small / Rear Bumper, Lamps, Panels - Scratch - Small / Trunk Hood, Rear Gate - Scratch - Minimal / (L) Rear Fender, Molding - Scratch - Minimal / (L) Rear Door, Molding - Scratch - Small / (L) Step, In-panel, Side Spoiler - Scratch & Dent - Minimal / (L) Front Door, Molding - Scratch - Small / (L) Front Fender, Molding - Scratch - Minimal / (L) Mirror - Scratch - Minimal / (R) Mirror - Scratch - Minimal / Bonnet, Headlight - Scratch & Dent - Minimal / Roof - Scratch & Dent - Small</p>

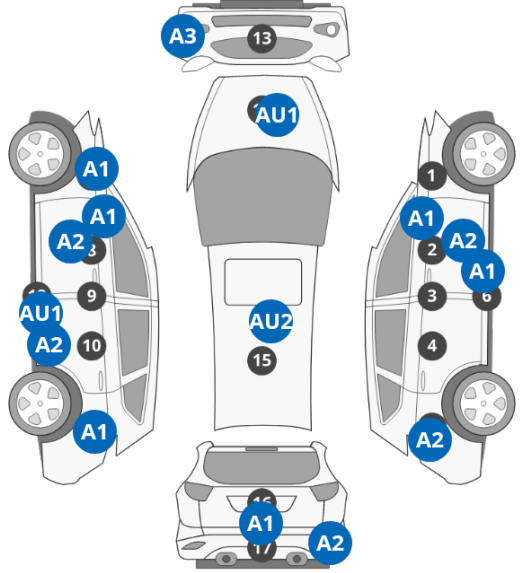
<p>Inspector Notes</p>
<p>With LTO plate and Sparetire, No Tools and Jack and Warranty booklet, No spare key, worn tires, foul smell, Scratch headlight and tail light.</p>
