General Information

Make	Toyota	Model	Wigo
YOM	2015	Odo Meter Reading	142,703
Registration No.	AAH3148	Chassis No.	MHKA4DF3F0J004071
CC	1.0	Transmission	A/T
Fuel Type	Gas	Type of Body	Hatchback
Colour	Black

Body / Panel Condition

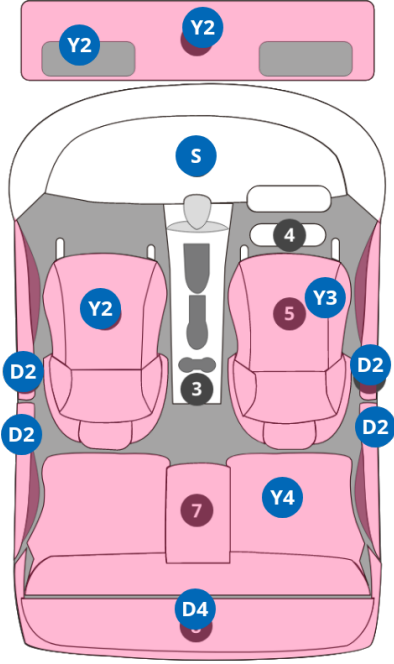
Interior Evaluation : C	Exterior Evaluation : E

<p>a : Cut, Fray d : Loose, Deformed k : Animal Hair s : Smell t : Cigarette Burns x : Defective y : Stain</p>

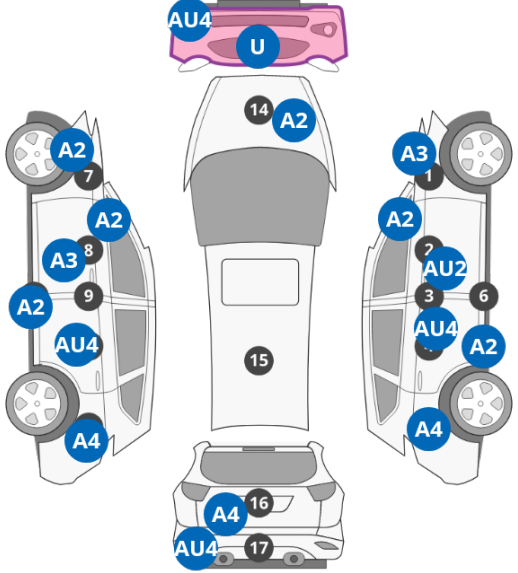
<p>A : Scratch AU : Scratch & Dent B : Modified C : Corrosion G : Stone chip P : Faded S : Rust SC : Rust & Corrosion U : Dent X : Defective Y : Crack, Gap</p>
<p>Remarks Ceiling - Grime - Small / Sunvisor, Sunglass Holder - Grime - Small / (R) Front Seat - Grime - Medium / Rear Seat - Grime - Large / (L) Front Trim - Worked - Small / (L) Rear Trim - Worked - Small / (R) Front Trim - Worked - Small / (R) Rear Trim - Worked - Small / Overall Interior - Worn as per age - Yes / Overall Interior - Smell - Yes / Trunk Room - Loose, Deformed - Large / (L) Front Seat - Grime - Small</p>	<p>Remarks (R) Front Door - Repair Traces - Yes / (R) Step - Repair Traces - Yes / (R) Front Fender - Repair Traces - Yes / Bonnet - Repair Traces - Yes / (L) Front Fender - Repair Traces - Yes / (L) Step - Repair Traces - Yes / Trunk Hood, Rear Gate - Repair Traces - Yes / (R) Rear Fender - Repair Traces - Yes / (R) Rear Door - Repair Traces - Yes / Roof - Repair Traces - Yes / (R) Mirror - Scratch - Small / (R) Front Door, Molding - Scratch & Dent - Small / (R) Rear Door, Molding - Scratch & Dent - Large / (R) Rear Fender, Molding - Scratch - Large / (R) Step, In-panel, Side Spoiler - Scratch - Small / Trunk Hood, Rear Gate - Scratch - Large / Rear Bumper, Lamps, Panels - Scratch & Dent - Large / (L) Rear Fender, Molding - Scratch - Large / (L) Rear Door, Molding - Scratch & Dent - Large / (L) Front Door, Molding - Scratch - Medium / (L) Mirror - Scratch - Small / (L) Front Fender, Molding - Scratch - Small / (L) Step, In-panel, Side Spoiler - Scratch - Small / Overall Exterior - Faded(Color, Gloss) - Yes / Overall Exterior - Worn as per age - Yes / Front Bumper, Grille, Lamps - Repair mark - Yes / Member (Bolted) - Dent - Yes / Front Bumper, Grille, Lamps - Scratch & Dent - Large / (R) Front Fender, Molding - Scratch - Medium / Bonnet, Headlight - Scratch - Small</p>
