General Information

Make	Mitsubishi	Model	Mirage
YOM	2023	Odo Meter Reading	22,612
Registration No.	NHL1956	Chassis No.	PAEA13TJPPA010885
CC	1.2	Transmission	A/T
Fuel Type	Gas	Type of Body	Sedan
Colour	Red

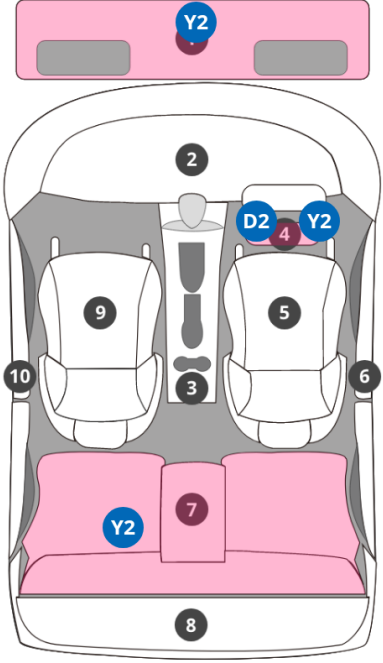
Interior Evaluation : A	Exterior Evaluation : C

<p>a : Cut, Fray d : Loose, Deformed k : Animal Hair s : Smell t : Cigarette Burns x : Defective y : Stain</p>

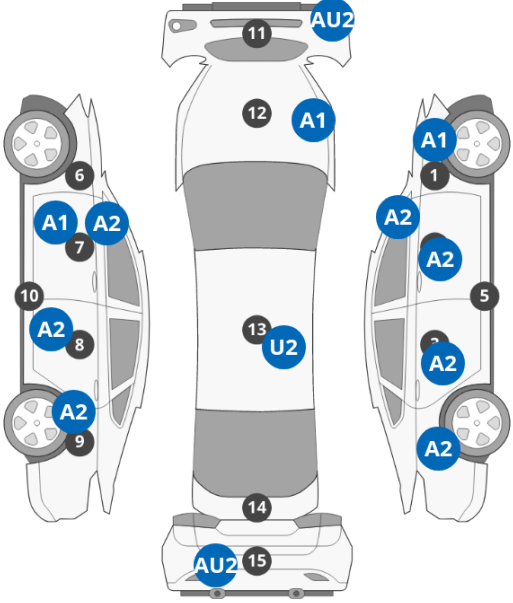
<p>A : Scratch AU : Scratch & Dent B : Modified C : Corrosion G : Stone chip P : Faded S : Rust SC : Rust & Corrosion U : Dent X : Defective Y : Crack, Gap</p>
<p>Remarks Ceiling - Grime - Small / (R) Front Floor Mat - Grime - Small / Rear Seat - Grime - Small / (L) Front Floor Mat - Worked - Small</p>	<p>Remarks (L) Rear Fender, Molding - Scratch - Small / (L) Mirror - Scratch - Small / (L) Rear Door, Molding - Scratch - Small / (L) Front Door, Molding - Scratch - Minimal / Bonnet, Headlight - Scratch - Minimal / Front Bumper, Grille, Lamps - Scratch & Dent - Small / (R) Mirror - Scratch - Small / (R) Front Fender, Molding - Scratch - Minimal / (R) Front Door, Molding - Scratch - Small / (R) Rear Door, Molding - Scratch - Small / (R) Rear Fender, Molding - Scratch - Small / Rear Bumper, Lamps, Panels - Scratch & Dent - Small / Roof - Dent - Small</p>
