General Information

Make	Toyota	Model	Vios
YOM	2024	Odo Meter Reading	6,848
Registration No.	GBE3852	Chassis No.	PA1B18F34R4253967
CC	1.3	Transmission	CVT
Fuel Type	Gas	Type of Body	Sedan
Colour	Red Mica Metallic

Body / Panel Condition

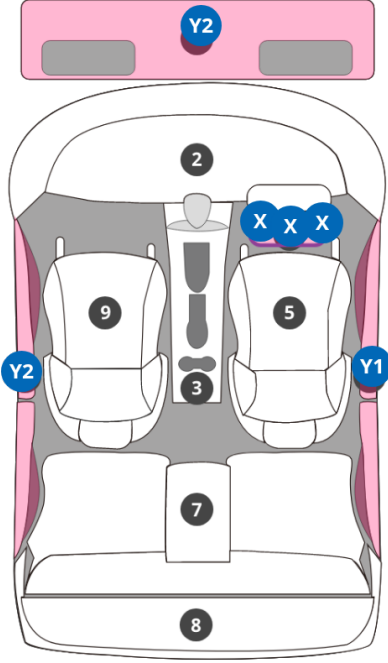
Interior Evaluation : B	Exterior Evaluation : C

<p>a : Cut, Fray d : Loose, Deformed k : Animal Hair s : Smell t : Cigarette Burns x : Defective y : Stain</p>

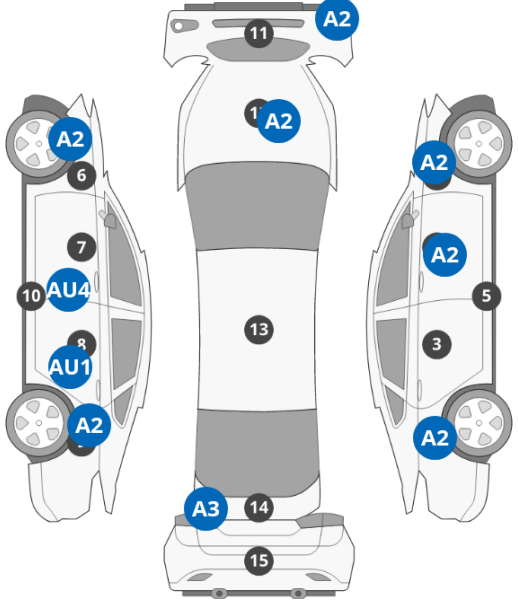
<p>A : Scratch AU : Scratch & Dent B : Modified C : Corrosion G : Stone chip P : Faded S : Rust SC : Rust & Corrosion U : Dent X : Defective Y : Crack, Gap</p>
<p>Remarks (R) Front Floor Mat - Missing - Yes / (L) Front Floor Mat - Missing - Yes / Mat Other - Missing - Yes / Ceiling - Grime - Small / (L) Front Trim - Grime - Small / (R) Front Trim - Grime - Minimal</p>	<p>Remarks (L) Front Door, Molding - Scratch & Dent - Large / (L) Rear Door, Molding - Scratch & Dent - Minimal / (L) Front Fender, Molding - Scratch - Small / (L) Rear Fender, Molding - Scratch - Small / Trunk Hood, Rear Gate - Scratch - Medium / (R) Rear Fender, Molding - Scratch - Small / (R) Front Fender, Molding - Scratch - Small / (R) Front Door, Molding - Scratch - Small / Bonnet, Headlight - Scratch - Small / Front Bumper, Grille, Lamps - Scratch - Small</p>
