General Information

Make	Toyota	Model	Veloz
YOM	2025	Odo Meter Reading	6,736
Registration No.	NKO5669	Chassis No.	MHFAB1BY6S3134217
CC	1.5	Transmission	CVT
Fuel Type	Gas	Type of Body	Wagon
Colour	Black

Body / Panel Condition

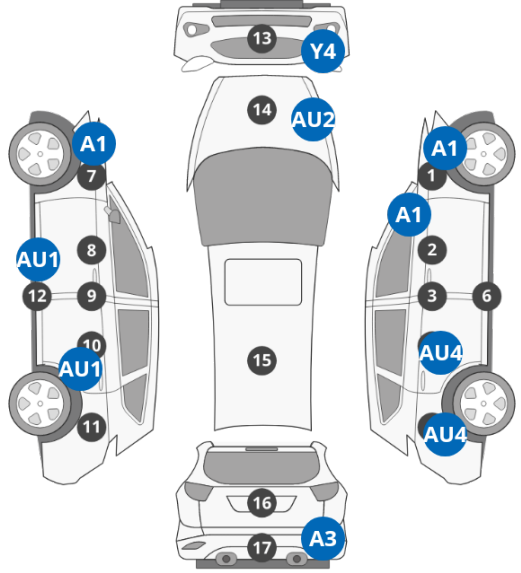
Interior Evaluation :	A	Exterior Evaluation :	C

<p>a : Cut, Fray d : Loose, Deformed k : Animal Hair s : Smell t : Cigarette Burns x : Defective y : Stain</p>		<p>A : Scratch AU : Scratch & Dent B : Modified C : Corrosion G : Stone chip P : Faded S : Rust SC : Rust & Corrosion U : Dent X : Defective Y : Crack, Gap</p>	
<p>Remarks Defects not found</p>		<p>Remarks (R) Front Fender, Molding - Scratch - Minimal / (R) Mirror - Scratch - Minimal / (R) Rear Door, Molding - Scratch & Dent - Large / (R) Rear Fender, Molding - Scratch & Dent - Large / Rear Bumper, Lamps, Panels - Scratch - Medium / (L) Rear Door, Molding - Scratch & Dent - Minimal / (L) Step, In-panel, Side Spoiler - Scratch & Dent - Minimal / (L) Front Fender, Molding - Scratch - Minimal / Front Bumper, Grille, Lamps - Crack, Gap - Large / Bonnet, Headlight - Scratch & Dent - Small</p>	
Frame Evaluation :	A	Functional Evaluation :	A

With Lto plate, with spare tire and jack, 1key, no warranty booklet, no tools, scratches on headlights
