## General Information

<b>Make</b>	Toyota	<b>Model</b>	Vios
<b>YOM</b>	2024	<b>Odo Meter Reading</b>	11,265
<b>Registration No.</b>	NKD2343	<b>Chassis No.</b>	PA1B18F34R4255511
<b>CC</b>	1.3	<b>Transmission</b>	CVT
<b>Fuel Type</b>	Gas	<b>Type of Body</b>	Sedan
<b>Colour</b>	Silver

## Body / Panel Condition

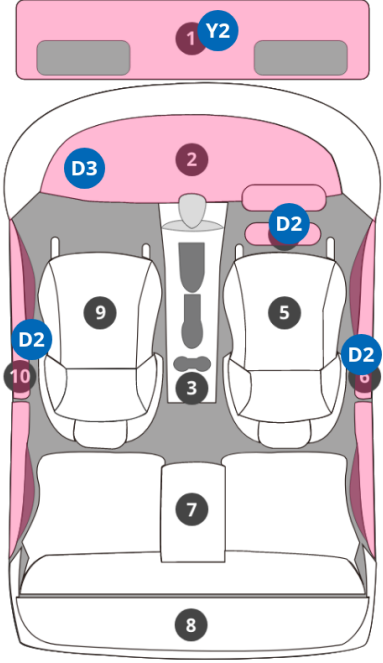
<p><b>a</b> : Cut, Fray <b>d</b> : Loose, Deformed <b>k</b> : Animal Hair <b>s</b> : Smell <b>t</b> : Cigarette Burns <b>x</b> : Defective <b>y</b> : Stain</p>

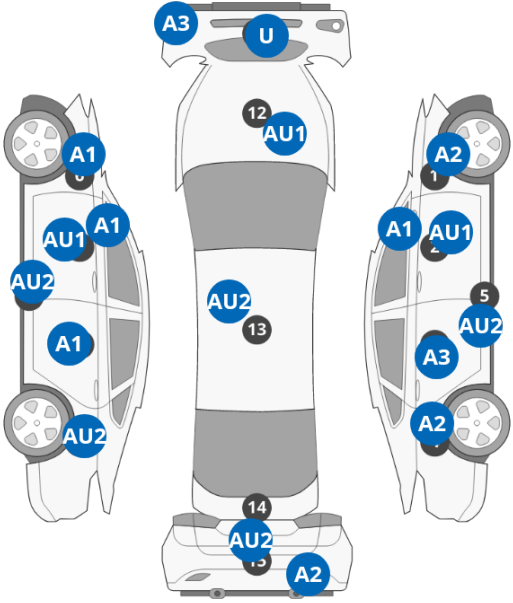
<p><b>A</b> : Scratch <b>AU</b> : Scratch &amp; Dent <b>B</b> : Modified <b>C</b> : Corrosion <b>G</b> : Stone chip <b>P</b> : Faded <b>S</b> : Rust <b>SC</b> : Rust &amp; Corrosion <b>U</b> : Dent <b>X</b> : Defective <b>Y</b> : Crack, Gap</p>
<p><b>Remarks</b> (L) Front Floor Mat - Worked - Small / Ceiling - Grime - Small / (L) Front Trim - Worked - Small / (R) Front Trim - Worked - Small / Dashboard - Loose, Deformed - Medium</p>	<p><b>Remarks</b> Member (Bolted) - Dent - Yes / (L) Front Fender, Molding - Scratch - Minimal / (L) Front Door, Molding - Scratch &amp; Dent - Minimal / (L) Rear Door, Molding - Scratch - Minimal / (L) Rear Fender, Molding - Scratch &amp; Dent - Small / (L) Step, In-panel, Side Spoiler - Scratch &amp; Dent - Small / Front Bumper, Grille, Lamps - Scratch - Medium / Bonnet, Headlight - Scratch &amp; Dent - Minimal / (R) Front Fender, Molding - Scratch - Small / (R) Front Door, Molding - Scratch &amp; Dent - Minimal / (R) Step, In-panel, Side Spoiler - Scratch &amp; Dent - Small / (R) Rear Fender, Molding - Scratch - Small / (R) Mirror - Scratch - Minimal / (L) Mirror - Scratch - Minimal / (R) Rear Door, Molding - Scratch - Medium / Rear Bumper, Lamps, Panels - Scratch - Small / Trunk Hood, Rear Gate - Scratch &amp; Dent - Small / Roof - Scratch &amp; Dent - Small</p>
