## General Information

<b>Make</b>	Toyota	<b>Model</b>	Wigo
<b>YOM</b>	2025	<b>Odo Meter Reading</b>	4,245
<b>Registration No.</b>	GBJ8782	<b>Chassis No.</b>	MHKAA1BCXSJ037302
<b>CC</b>	1.0	<b>Transmission</b>	CVT
<b>Fuel Type</b>	Gas	<b>Type of Body</b>	Hatchback
<b>Colour</b>	Gray

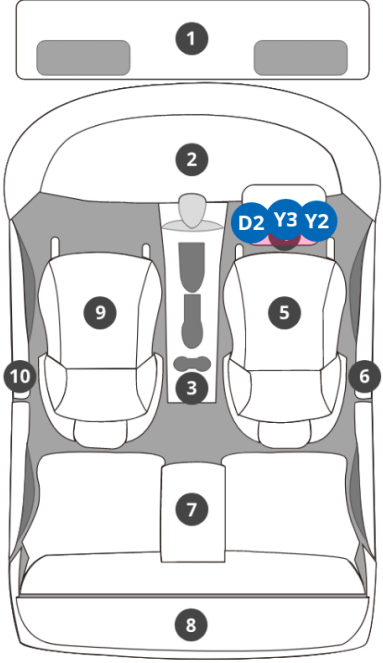
<b>Interior Evaluation :</b> <span style="float: right; color: red; font-weight: bold;">B</span>	<b>Exterior Evaluation :</b> <span style="float: right; color: red; font-weight: bold;">D</span>

<p><b>a</b> : Cut, Fray <b>d</b> : Loose, Deformed <b>k</b> : Animal Hair <b>s</b> : Smell <b>t</b> : Cigarette Burns <b>x</b> : Defective <b>y</b> : Stain</p>

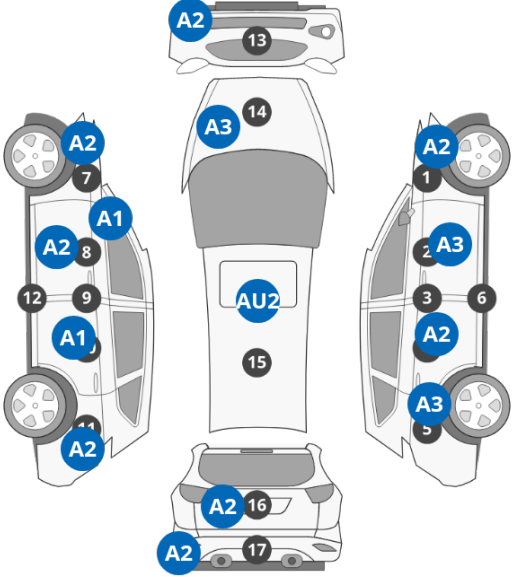
<p><b>A</b> : Scratch <b>AU</b> : Scratch &amp; Dent <b>B</b> : Modified <b>C</b> : Corrosion <b>G</b> : Stone chip <b>P</b> : Faded <b>S</b> : Rust <b>SC</b> : Rust &amp; Corrosion <b>U</b> : Dent <b>X</b> : Defective <b>Y</b> : Crack, Gap</p>
<p><b>Remarks</b> (L) Front Floor Mat - Worked - Small / Mat Other - Grime - Medium / (R) Front Floor Mat - Grime - Small</p>	<p><b>Remarks</b> Roof - Scratch &amp; Dent - Small / (R) Front Fender, Molding - Scratch - Small / (R) Front Door, Molding - Scratch - Medium / (R) Rear Door, Molding - Scratch - Small / (R) Rear Fender, Molding - Scratch - Medium / (L) Rear Fender, Molding - Scratch - Small / (L) Front Fender, Molding - Scratch - Small / (L) Front Door, Molding - Scratch - Small / (L) Mirror - Scratch - Minimal / Rear Bumper, Lamps, Panels - Scratch - Small / Trunk Hood, Rear Gate - Scratch - Small / Bonnet, Headlight - Scratch - Medium / Front Bumper, Grille, Lamps - Scratch - Small / (L) Rear Door, Molding - Scratch - Minimal</p>
