General Information

Make	Toyota	Model	Hiace
YOM	2021	Odo Meter Reading	46,206
Registration No.	NEF7552	Chassis No.	JTFNAFAP7L8018848
CC	2.8	Transmission	M/T
Fuel Type	Diesel	Type of Body	Van
Colour	Silver

Body / Panel Condition

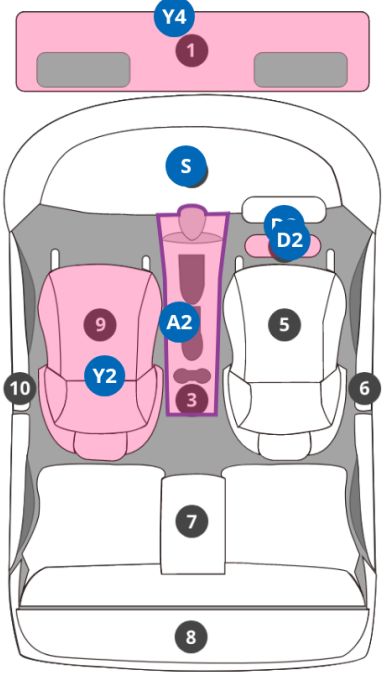
Interior Evaluation : C	Exterior Evaluation : E

<p>a : Cut, Fray d : Loose, Deformed k : Animal Hair s : Smell t : Cigarette Burns x : Defective y : Stain</p>

<p>A : Scratch AU : Scratch & Dent B : Modified C : Corrosion G : Stone chip P : Faded S : Rust SC : Rust & Corrosion U : Dent X : Defective Y : Crack, Gap</p>
<p>Remarks Display, Audio System - Missing - Yes / Overall Interior - Worn as per age - Yes / Overall Interior - Smell - Yes / (L) Front Seat - Grime - Small / Knobs - Worn, Peel, Crack - Small / Ceiling - Grime - Large / (L) Front Floor Mat - Worked - Small / (R) Front Floor Mat - Worked - Small</p>	<p>Remarks (R) Front Fender, Molding - Scratch - Small / (R) Mirror - Scratch - Small / (R) Front Door, Molding - Scratch - Small / (R) Center Panel - Scratch - Small / (R) Rear Door, Molding - Scratch - Small / (R) Rear Fender, Molding - Scratch & Dent - Medium / Rear Bumper, Lamps, Panels - Scratch & Dent - Medium / Trunk Hood, Rear Gate - Scratch & Dent - Medium / (L) Rear Fender, Molding - Scratch & Dent - Large / (L) Rear Door, Molding - Scratch - Medium / (L) Front Fender, Molding - Scratch - Medium / (L) Front Door, Molding - Scratch - Small / (L) Mirror - Scratch - Small / Bonnet, Headlight - Scratch - Medium / Front Bumper, Grille, Lamps - Scratch & Dent - Medium / Roof - Scratch - Small</p>

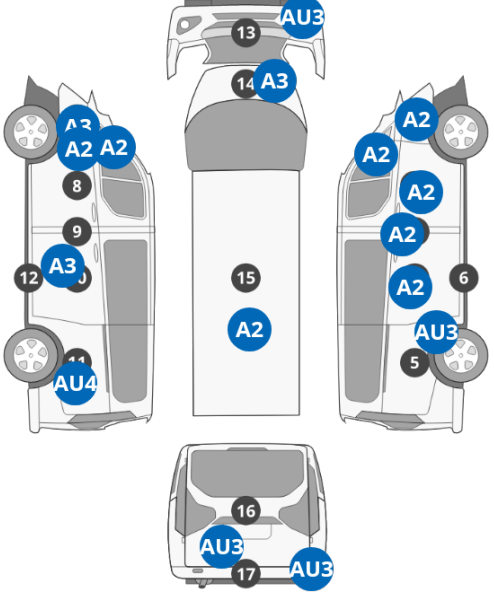
<p>Inspector Notes</p>
<p>no warranty booklet, no jack and tools, no spare tire, with LTO plate, scratches on headlight and tail light, radio unit missing,</p>
