General Information

Make	Toyota	Model	Fortuner
YOM	2023	Odo Meter Reading	28,942
Registration No.	NHJ7980	Chassis No.	MHFCB8GS8N0528331
CC	2.4	Transmission	M/T
Fuel Type	Diesel	Type of Body	SUV
Colour	Silver

Body / Panel Condition

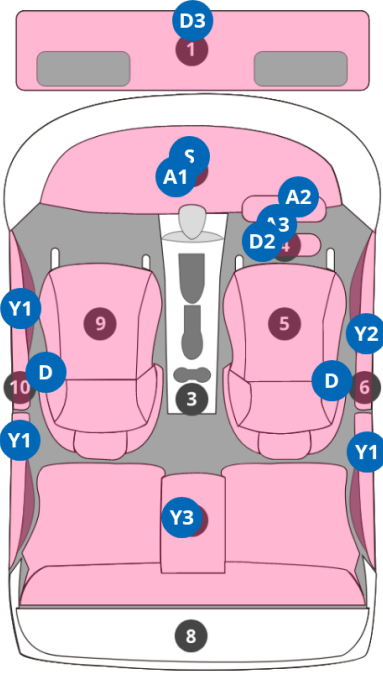
Interior Evaluation : C	Exterior Evaluation : E

<p>a : Cut, Fray d : Loose, Deformed k : Animal Hair s : Smell t : Cigarette Burns x : Defective y : Stain</p>

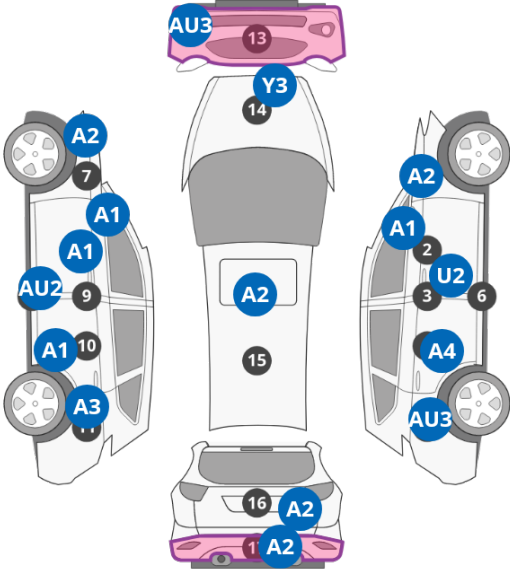
<p>A : Scratch AU : Scratch & Dent B : Modified C : Corrosion G : Stone chip P : Faded S : Rust SC : Rust & Corrosion U : Dent X : Defective Y : Crack, Gap</p>
<p>Remarks Overall Interior - Smell - Yes / (L) Front Seat - Worn - Yes / (R) Front Seat - Worn - Yes / (L) Front Floor Mat - Cut, Crack - Medium / (L) Front Floor Mat - Worked - Small / Glove Box - Worn, Scratch, Cut, Crack - Small / Rear Seat - Grime - Medium / (L) Rear Trim - Grime - Minimal / (R) Rear Trim - Grime - Minimal / (R) Front Trim - Grime - Small / (L) Front Trim - Grime - Minimal / Dashboard - Worn, Scratch, Cut, Crack - Minimal / Ceiling - Crinkle - Medium</p>	<p>Remarks (R) Front Door - Repair Traces - Yes / (L) Rear Door - Repair Traces - Yes / Trunk Hood, Rear Gate - Repair Traces - Yes / (R) Rear Fender - Repair Traces - Yes / (R) Rear Door - Repair Traces - Yes / (R) Front Fender, Molding - Scratch - Small / (R) Mirror - Scratch - Minimal / (L) Mirror - Scratch - Minimal / (R) Front Door, Molding - Dent - Small / (R) Rear Door, Molding - Scratch - Large / (R) Rear Fender, Molding - Scratch & Dent - Medium / Rear Bumper, Lamps, Panels - Scratch - Small / Trunk Hood, Rear Gate - Scratch - Small / Rear Bumper, Lamps, Panels - Repair mark - Yes / Front Bumper, Grille, Lamps - Repair mark - Yes / (L) Rear Fender, Molding - Scratch - Medium / (L) Rear Door, Molding - Scratch - Minimal / (L) Front Door, Molding - Scratch - Minimal / (L) Front Fender, Molding - Scratch - Small / Front Bumper, Grille, Lamps - Scratch & Dent - Medium / Bonnet, Headlight - Crack, Gap - Medium / Roof - Scratch - Small / (L) Step, In-panel, Side Spoiler - Scratch & Dent - Small</p>
