General Information

Make	Toyota	Model	Vios
YOM	2023	Odo Meter Reading	22,917
Registration No.	NFC7158-1	Chassis No.	PA1B18F38P4221746
CC	1.3	Transmission	CVT
Fuel Type	Gas	Type of Body	Sedan
Colour	Black

Body / Panel Condition

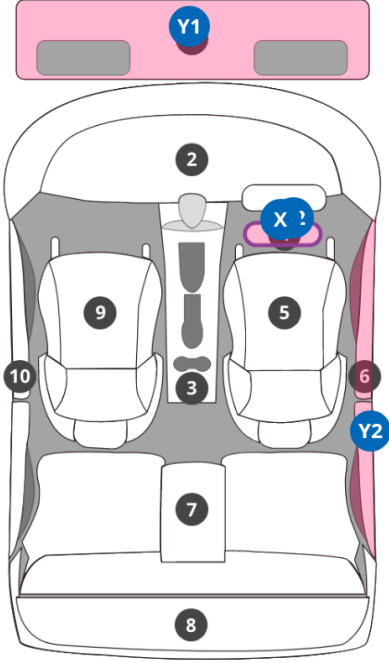
Interior Evaluation : B	Exterior Evaluation : C

<p>a : Cut, Fray d : Loose, Deformed k : Animal Hair s : Smell t : Cigarette Burns x : Defective y : Stain</p>

<p>A : Scratch AU : Scratch & Dent B : Modified C : Corrosion G : Stone chip P : Faded S : Rust SC : Rust & Corrosion U : Dent X : Defective Y : Crack, Gap</p>
<p>Remarks Mat Other - Grime - Small / (L) Front Floor Mat - Missing - Yes / Ceiling - Grime - Minimal / (R) Rear Trim - Grime - Small</p>	<p>Remarks (R) Front Fender, Molding - Dent - Small / (R) Mirror - Scratch - Minimal / (R) Front Door, Molding - Scratch - Small / (R) Rear Door, Molding - Scratch - Small / (R) Step, In-panel, Side Spoiler - Scratch - Minimal / (R) Rear Fender, Molding - Scratch - Minimal / Trunk Hood, Rear Gate - Scratch - Small / Rear Bumper, Lamps, Panels - Crack, Gap - Large / (L) Rear Fender, Molding - Scratch - Minimal / (L) Rear Door, Molding - Scratch - Minimal / (L) Front Door, Molding - Scratch - Small / (L) Front Fender, Molding - Scratch & Dent - Small / Front Bumper, Grille, Lamps - Crack, Gap - Large / Roof - Dent - Minimal / Bonnet, Headlight - Scratch - Small</p>

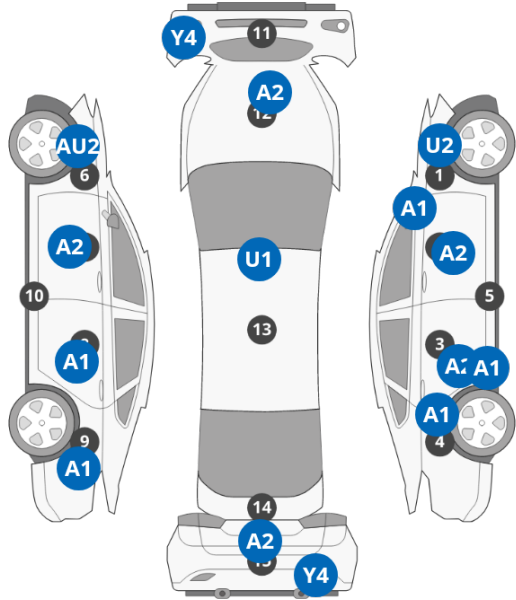
<p>Inspector Notes</p>
<p>With Lto plate, with jack and spare tire, 1key, no warranty booklet, no tools, Crack tail light, foul smell possible flooded</p>
