General Information

Make	Toyota	Model	Vios
YOM	2025	Odo Meter Reading	14,159
Registration No.	DBR3788	Chassis No.	PA1B18F37R4269614
CC	1.3	Transmission	CVT
Fuel Type	Gas	Type of Body	Sedan
Colour	Silver

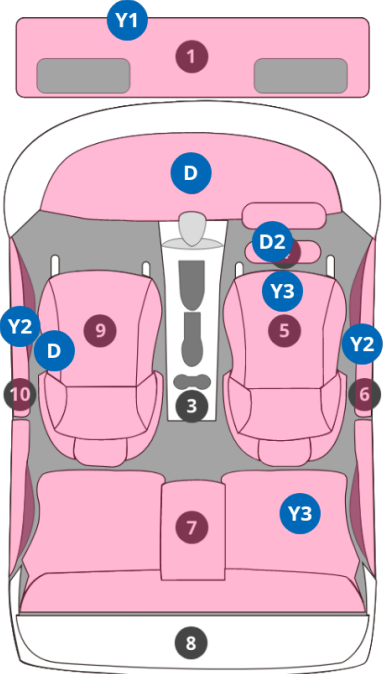
Interior Evaluation : C	Exterior Evaluation : E

<p>a : Cut, Fray d : Loose, Deformed k : Animal Hair s : Smell t : Cigarette Burns x : Defective y : Stain</p>

<p>A : Scratch AU : Scratch & Dent B : Modified C : Corrosion G : Stone chip P : Faded S : Rust SC : Rust & Corrosion U : Dent X : Defective Y : Crack, Gap</p>
<p>Remarks (R) Front Seat - Grime - Medium / (L) Front Seat - Worn - Yes / Rear Seat - Grime - Medium / (R) Front Trim - Grime - Small / (L) Front Trim - Grime - Small / (R) Front Floor Mat - Worked - Small / Dashboard - Traces of Adhesive Tape - Yes / Ceiling - Grime - Minimal</p>	<p>Remarks (R) Front Fender, Molding - Scratch - Small / (R) Mirror - Scratch - Minimal / (R) Step, In-panel, Side Spoiler - Scratch & Dent - Medium / (R) Rear Door, Molding - Scratch - Small / (R) Front Door, Molding - Scratch - Medium / (R) Rear Fender, Molding - Scratch & Dent - Minimal / Rear Bumper, Lamps, Panels - Repair mark - Yes / Rear Bumper, Lamps, Panels - Scratch & Dent - Medium / Trunk Hood, Rear Gate - Scratch & Dent - Small / (L) Rear Fender, Molding - Scratch - Medium / (L) Rear Door, Molding - Scratch - Small / (L) Front Door, Molding - Scratch - Small / (L) Mirror - Scratch - Small / (L) Front Fender, Molding - Scratch - Minimal / Front Bumper, Grille, Lamps - Scratch & Dent - Small / Bonnet, Headlight - Crack, Gap - Medium / Roof - Dent - Small</p>

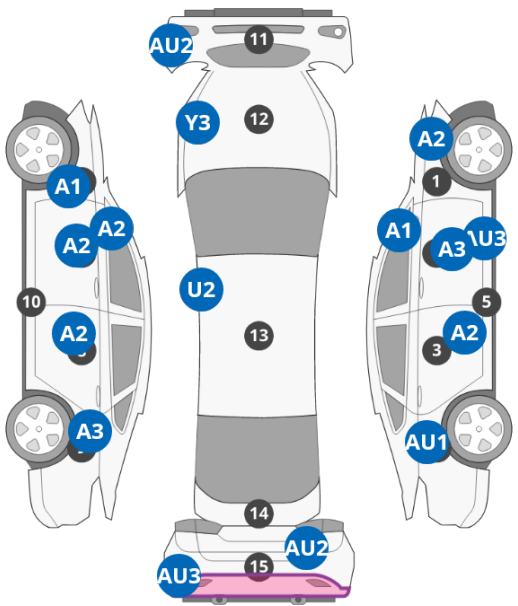
<p>Inspector Notes</p>
<p>with warranty booklet and jack, no tools, with spare tire, with LTO plate, scratches on tail light, head unit issue,</p>
