General Information

Make	Toyota	Model	Vios
YOM	2025	Odo Meter Reading	4,083
Registration No.	DBS3449	Chassis No.	PA1B18F37R4280564
CC	1.3	Transmission	CVT
Fuel Type	Gas	Type of Body	Sedan
Colour	Red

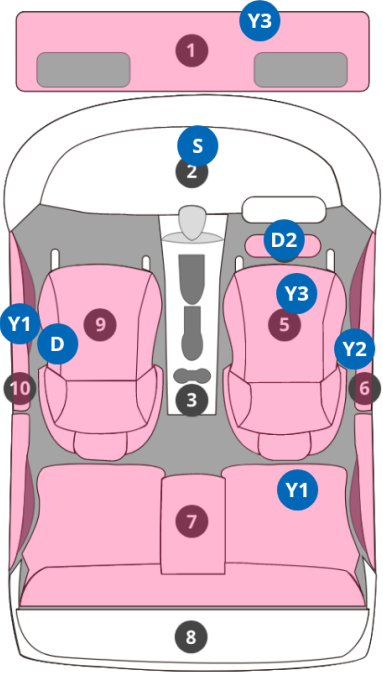
Interior Evaluation : B	Exterior Evaluation : C

<p>a : Cut, Fray d : Loose, Deformed k : Animal Hair s : Smell t : Cigarette Burns x : Defective y : Stain</p>

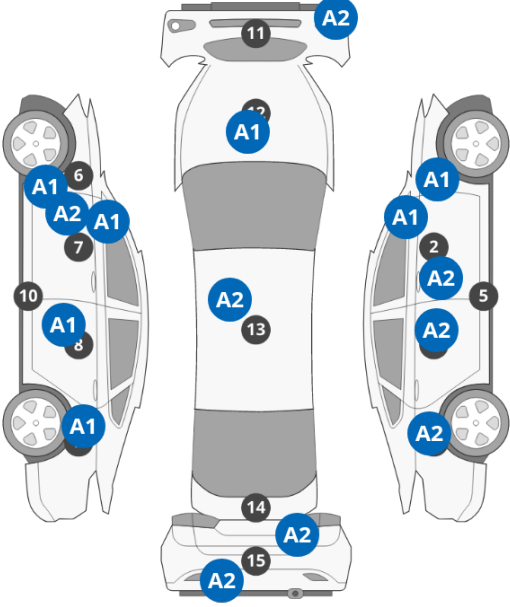
<p>A : Scratch AU : Scratch & Dent B : Modified C : Corrosion G : Stone chip P : Faded S : Rust SC : Rust & Corrosion U : Dent X : Defective Y : Crack, Gap</p>
<p>Remarks (R) Front Seat - Grime - Medium / (L) Front Seat - Worn - Yes / (R) Front Trim - Grime - Small / (L) Front Trim - Grime - Minimal / (L) Front Floor Mat - Worked - Small / Rear Seat - Grime - Minimal / Ceiling - Grime - Medium / Overall Interior - Smell - Yes</p>	<p>Remarks (R) Mirror - Scratch - Minimal / (R) Front Fender, Molding - Scratch - Minimal / (R) Rear Door, Molding - Scratch - Small / (R) Front Door, Molding - Scratch - Small / (R) Rear Fender, Molding - Scratch - Small / Rear Bumper, Lamps, Panels - Scratch - Small / Trunk Hood, Rear Gate - Scratch - Small / (L) Rear Fender, Molding - Scratch - Minimal / (L) Rear Door, Molding - Scratch - Minimal / (L) Front Door, Molding - Scratch - Small / (L) Mirror - Scratch - Minimal / (L) Front Fender, Molding - Scratch - Minimal / Front Bumper, Grille, Lamps - Scratch - Small / Bonnet, Headlight - Scratch - Minimal / Roof - Scratch - Small</p>

<p>Inspector Notes</p>
<p>no warranty booklet and tools, with jack and spare tire, with LTO plate, scratches on tail light</p>
