## General Information

<b>Make</b>	Toyota	<b>Model</b>	Vios
<b>YOM</b>	2025	<b>Odo Meter Reading</b>	6,653
<b>Registration No.</b>	DCA7669	<b>Chassis No.</b>	PA1B18F30S4292562
<b>CC</b>	1.3	<b>Transmission</b>	CVT
<b>Fuel Type</b>	Gas	<b>Type of Body</b>	Sedan
<b>Colour</b>	Black

## Body / Panel Condition

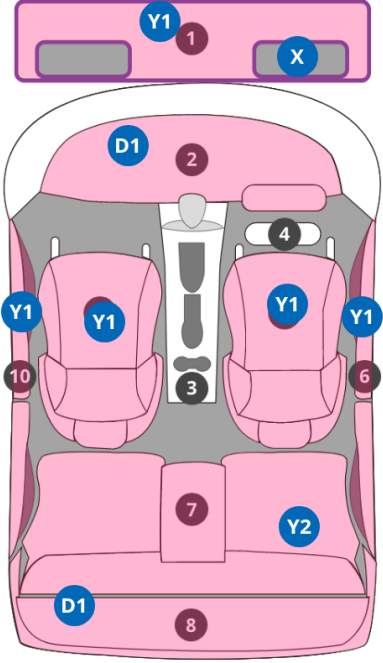
<b>Interior Evaluation :</b> <span style="float: right;"><b>B</b></span>	<b>Exterior Evaluation :</b> <span style="float: right;"><b>E</b></span>

<p><b>a</b> : Cut, Fray <b>d</b> : Loose, Deformed <b>k</b> : Animal Hair <b>s</b> : Smell <b>t</b> : Cigarette Burns <b>x</b> : Defective <b>y</b> : Stain</p>

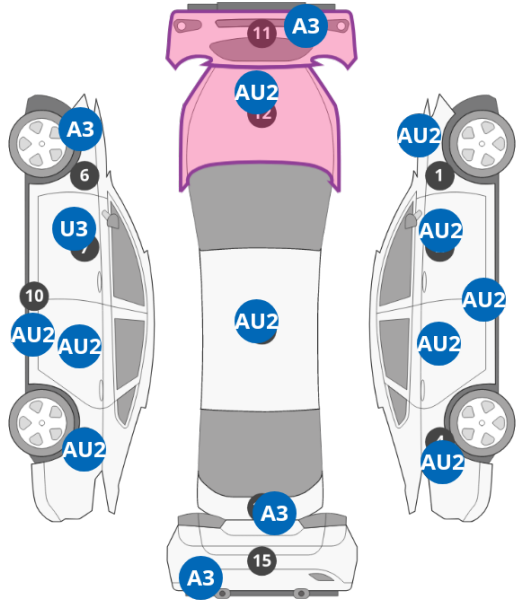
<p><b>A</b> : Scratch <b>AU</b> : Scratch &amp; Dent <b>B</b> : Modified <b>C</b> : Corrosion <b>G</b> : Stone chip <b>P</b> : Faded <b>S</b> : Rust <b>SC</b> : Rust &amp; Corrosion <b>U</b> : Dent <b>X</b> : Defective <b>Y</b> : Crack, Gap</p>
<p><b>Remarks</b> Ceiling - Grime - Minimal / Sunvisor, Sunglass Holder - Missing - Yes / Dashboard - Worked - Minimal / (L) Front Seat - Grime - Minimal / (R) Front Seat - Grime - Minimal / (L) Front Trim - Grime - Minimal / (R) Front Trim - Grime - Minimal / Rear Seat - Grime - Small / Trunk Room - Worked - Minimal</p>	<p><b>Remarks</b> (R) Front Fender - Repair Traces - Yes / Bonnet - Repair Traces - Yes / (L) Front Fender - Repair Traces - Yes / (L) Rear Fender, Molding - Scratch &amp; Dent - Small / (R) Rear Fender, Molding - Scratch &amp; Dent - Small / Trunk Hood, Rear Gate - Scratch - Medium / Rear Bumper, Lamps, Panels - Scratch - Medium / (L) Rear Door, Molding - Scratch &amp; Dent - Small / (L) Step, In-panel, Side Spoiler - Scratch &amp; Dent - Small / (L) Front Door, Molding - Dent - Medium / (L) Front Fender, Molding - Scratch - Medium / Bonnet, Headlight - Repair mark - Yes / Front Bumper, Grille, Lamps - Repair mark - Yes / Bonnet, Headlight - Scratch &amp; Dent - Small / Front Bumper, Grille, Lamps - Scratch - Medium / (R) Front Fender, Molding - Scratch &amp; Dent - Small / (R) Front Door, Molding - Scratch &amp; Dent - Small / (R) Step, In-panel, Side Spoiler - Scratch &amp; Dent - Small / (R) Rear Door, Molding - Scratch &amp; Dent - Small / Roof - Scratch &amp; Dent - Small</p>
