General Information

Make	Toyota	Model	Hilux
YOM	2021	Odo Meter Reading	28,932
Registration No.	NGB6331	Chassis No.	MR0JB8DD9L3533236
CC	2.4	Transmission	A/T
Fuel Type	Diesel	Type of Body	Pickup
Colour	Silver

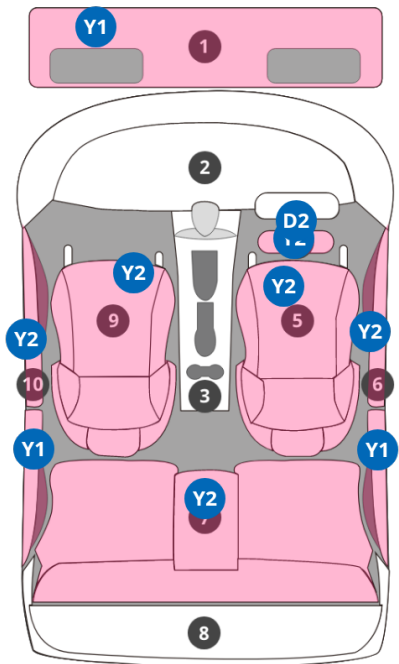
Interior Evaluation : B	Exterior Evaluation : E

<p>a : Cut, Fray d : Loose, Deformed k : Animal Hair s : Smell t : Cigarette Burns x : Defective y : Stain</p>

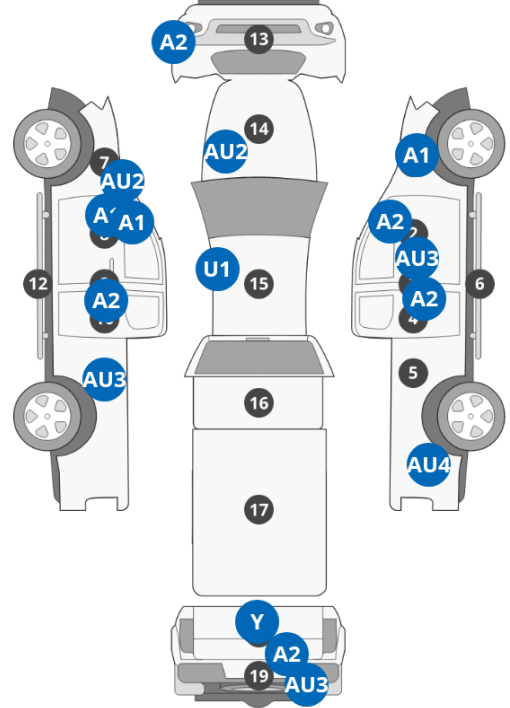
<p>A : Scratch AU : Scratch & Dent B : Modified C : Corrosion G : Stone chip P : Faded S : Rust SC : Rust & Corrosion U : Dent X : Defective Y : Crack, Gap</p>
<p>Remarks Rear Seat - Grime - Small / (R) Front Seat - Grime - Small / (L) Front Seat - Grime - Small / Mat Other - Grime - Small / (R) Front Trim - Grime - Small / (L) Front Trim - Grime - Small / (L) Front Floor Mat - Worked - Small / (R) Rear Trim - Grime - Minimal / (L) Rear Trim - Grime - Minimal / Ceiling - Grime - Minimal</p>	<p>Remarks (R) Front Fender - Repair Traces - Yes / (R) Front Fender, Molding - Scratch - Minimal / (R) Mirror - Scratch - Small / (R) Rear Door, Molding - Scratch - Small / (R) Side Gate - Scratch & Dent - Large / (R) Front Door, Molding - Scratch & Dent - Medium / Rear Bumper, Lamps, Panels - Scratch & Dent - Medium / Rear Gate - Scratch - Small / (L) Side Gate - Scratch & Dent - Medium / (L) Rear Door, Molding - Scratch - Small / (L) Front Door, Molding - Scratch - Minimal / (L) Mirror - Scratch - Minimal / (L) Front Fender, Molding - Scratch & Dent - Small / Front Bumper, Grille, Lamps - Scratch - Small / Bonnet, Headlight - Scratch & Dent - Small / Antennae - Damaged - Yes / Roof - Dent - Minimal</p>

<p>Inspector Notes</p>
<p>no warranty booklet, with jack, no tools, with spare tire, with LTO plate, scratched and cracked tail light</p>
