General Information

Make	Toyota	Model	Vios
YOM	2024	Odo Meter Reading	24,953
Registration No.	NFA9597	Chassis No.	PA1B18F3XP4232523
CC	1.3	Transmission	CVT
Fuel Type	Gas	Type of Body	Sedan
Colour	Blue

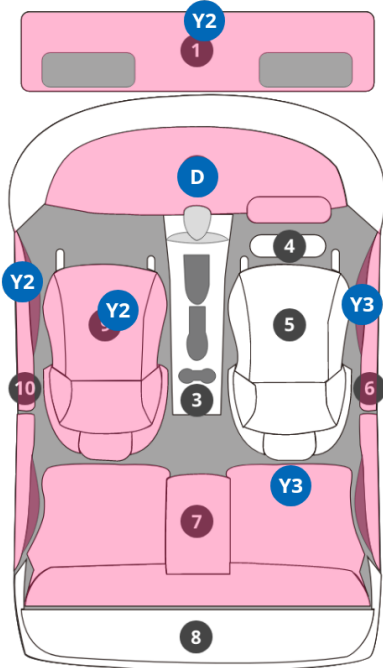
Interior Evaluation : B	Exterior Evaluation : C

<p>a : Cut, Fray d : Loose, Deformed k : Animal Hair s : Smell t : Cigarette Burns x : Defective y : Stain</p>

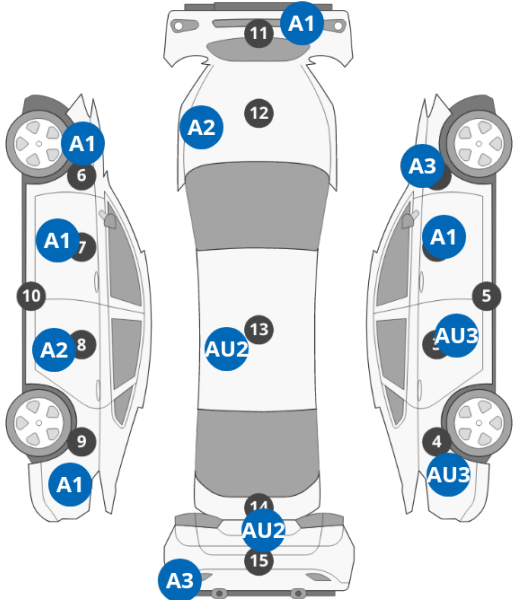
<p>A : Scratch AU : Scratch & Dent B : Modified C : Corrosion G : Stone chip P : Faded S : Rust SC : Rust & Corrosion U : Dent X : Defective Y : Crack, Gap</p>
<p>Remarks Rear Seat - Grime - Medium / (R) Front Trim - Grime - Medium / (L) Front Trim - Grime - Small / (L) Front Seat - Grime - Small / Ceiling - Grime - Small / Dashboard - Traces of Adhesive Tape - Yes</p>	<p>Remarks Roof - Scratch & Dent - Small / (L) Rear Door, Molding - Scratch - Small / Trunk Hood, Rear Gate - Scratch & Dent - Small / Rear Bumper, Lamps, Panels - Scratch - Medium / (R) Rear Fender, Molding - Scratch & Dent - Medium / (R) Rear Door, Molding - Scratch & Dent - Medium / (R) Front Door, Molding - Scratch - Minimal / (R) Front Fender, Molding - Scratch - Medium / Bonnet, Headlight - Scratch - Small / Front Bumper, Grille, Lamps - Scratch - Minimal / (L) Front Fender, Molding - Scratch - Minimal / (L) Front Door, Molding - Scratch - Minimal / (L) Rear Fender, Molding - Scratch - Minimal</p>
