## General Information

<b>Make</b>	Toyota	<b>Model</b>	Vios
<b>YOM</b>	2022	<b>Odo Meter Reading</b>	69,029
<b>Registration No.</b>	NFJ1157	<b>Chassis No.</b>	PA1B18F38N4170584
<b>CC</b>	1.3	<b>Transmission</b>	CVT
<b>Fuel Type</b>	Gas	<b>Type of Body</b>	Sedan
<b>Colour</b>	Blue

## Body / Panel Condition

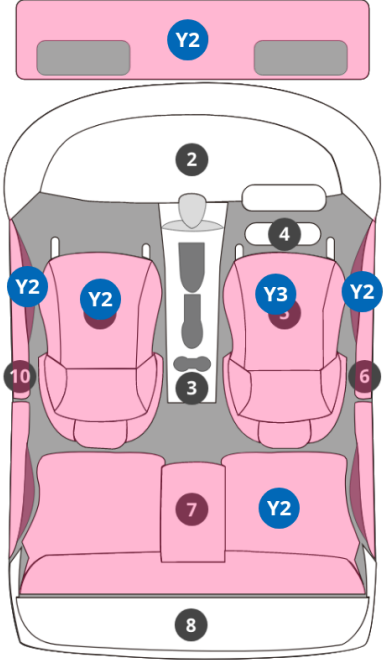
<p><b>a</b> : Cut, Fray <b>d</b> : Loose, Deformed <b>k</b> : Animal Hair <b>s</b> : Smell <b>t</b> : Cigarette Burns <b>x</b> : Defective <b>y</b> : Stain</p>

<p><b>A</b> : Scratch <b>AU</b> : Scratch &amp; Dent <b>B</b> : Modified <b>C</b> : Corrosion <b>G</b> : Stone chip <b>P</b> : Faded <b>S</b> : Rust <b>SC</b> : Rust &amp; Corrosion <b>U</b> : Dent <b>X</b> : Defective <b>Y</b> : Crack, Gap</p>
<p><b>Remarks</b> Rear Seat - Grime - Small / (R) Front Trim - Grime - Small / (R) Front Seat - Grime - Medium / (L) Front Trim - Grime - Small / (L) Front Seat - Grime - Small / Ceiling - Grime - Small</p>	<p><b>Remarks</b> (L) Front Door, Molding - Scratch &amp; Dent - Small / (L) Front Fender, Molding - Repair mark - Yes / (L) Front Fender, Molding - Scratch - Small / Bonnet, Headlight - Scratch - Minimal / Front Bumper, Grille, Lamps - Scratch - Large / (R) Front Fender, Molding - Scratch &amp; Dent - Small / (R) Front Door, Molding - Scratch &amp; Dent - Medium / (R) Rear Door, Molding - Scratch &amp; Dent - Medium / (R) Rear Fender, Molding - Scratch - Minimal / Trunk Hood, Rear Gate - Dent - Small / (L) Rear Fender, Molding - Scratch - Small / (L) Rear Door, Molding - Scratch - Small / Rear Bumper, Lamps, Panels - Scratch - Small / Roof - Scratch - Minimal</p>
