## General Information

<b>Make</b>	Toyota	<b>Model</b>	Raize
<b>YOM</b>	2024	<b>Odo Meter Reading</b>	29,866
<b>Registration No.</b>	NHM1695	<b>Chassis No.</b>	MHKAA1BA9PJ106907
<b>CC</b>	1.0	<b>Transmission</b>	CVT
<b>Fuel Type</b>	Gas	<b>Type of Body</b>	SUV
<b>Colour</b>	White

## Body / Panel Condition

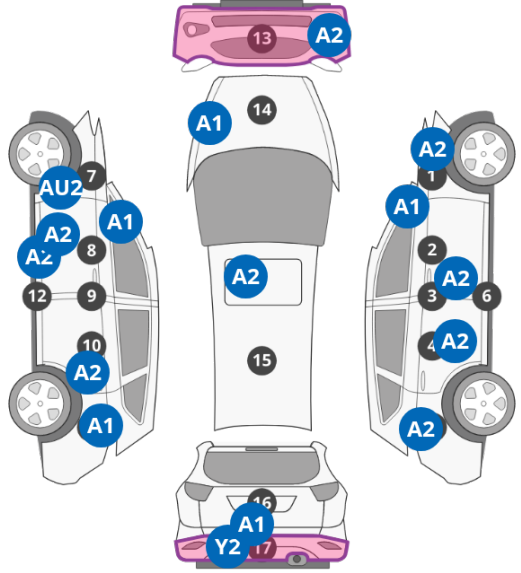
<p><b>A</b> : Scratch <b>AU</b> : Scratch &amp; Dent <b>B</b> : Modified <b>C</b> : Corrosion <b>G</b> : Stone chip <b>P</b> : Faded <b>S</b> : Rust <b>SC</b> : Rust &amp; Corrosion <b>U</b> : Dent <b>X</b> : Defective <b>Y</b> : Crack, Gap</p>
<p><b>Remarks</b> Rear Seat - Grime - Large / Overall Interior - Smell - Yes / (R) Front Seat - Grime - Medium / (L) Front Seat - Grime - Medium / Ceiling - Crinkle - Small</p>	<p><b>Remarks</b> (R) Front Fender, Molding - Scratch - Small / (R) Rear Door, Molding - Scratch - Small / (R) Front Door, Molding - Scratch - Small / (R) Mirror - Scratch - Minimal / (R) Rear Fender, Molding - Scratch - Small / Rear Bumper, Lamps, Panels - Repair mark - Yes / Rear Bumper, Lamps, Panels - Crack, Gap - Small / Trunk Hood, Rear Gate - Scratch - Minimal / (L) Rear Fender, Molding - Scratch - Minimal / (L) Rear Door, Molding - Scratch - Small / (L) Step, In-panel, Side Spoiler - Scratch - Small / (L) Front Fender, Molding - Scratch &amp; Dent - Small / (L) Front Door, Molding - Scratch - Small / (L) Mirror - Scratch - Minimal / Front Bumper, Grille, Lamps - Repair mark - Yes / Front Bumper, Grille, Lamps - Scratch - Small / Bonnet, Headlight - Scratch - Minimal / Roof - Scratch - Small</p>

<p><b>Inspector Notes</b></p>
<p>no warranty booklet, with jack and tools, with spare tire, with LTO plate, scratches on tail light and headlight</p>
