General Information

Make	Toyota	Model	Vios
YOM	2024	Odo Meter Reading	20,629
Registration No.	NKA2840	Chassis No.	PA1B18F32R4244054
CC	1.3	Transmission	CVT
Fuel Type	Gas	Type of Body	Sedan
Colour	Green

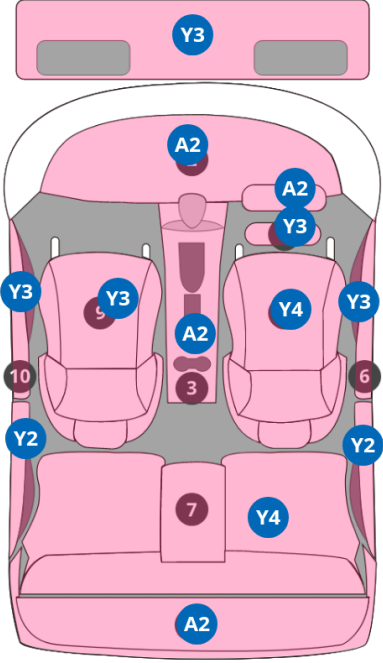
Interior Evaluation : E	Exterior Evaluation : E

<p>a : Cut, Fray d : Loose, Deformed k : Animal Hair s : Smell t : Cigarette Burns x : Defective y : Stain</p>

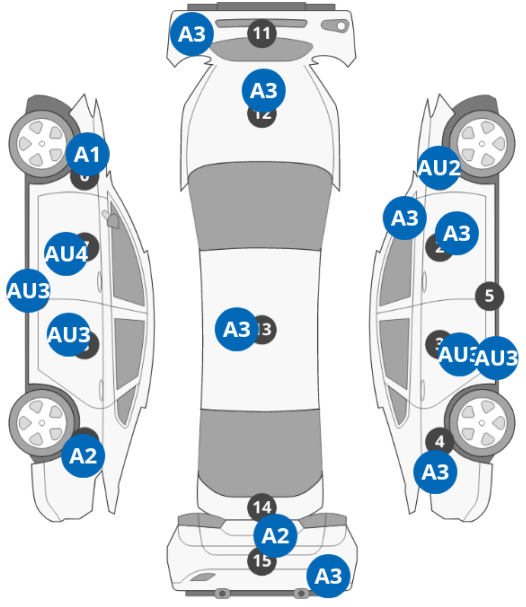
<p>A : Scratch AU : Scratch & Dent B : Modified C : Corrosion G : Stone chip P : Faded S : Rust SC : Rust & Corrosion U : Dent X : Defective Y : Crack, Gap</p>
<p>Remarks Trunk Room - Worn, Scratch, Cut, Crack - Small / Rear Seat - Grime - Large / (R) Front Trim - Grime - Medium / (R) Front Seat - Grime - Large / (L) Rear Trim - Grime - Small / (R) Rear Trim - Grime - Small / (L) Front Trim - Grime - Medium / (L) Front Seat - Grime - Medium / (L) Front Floor Mat - Grime - Medium / Dashboard - Worn, Scratch, Cut, Crack - Small / Console, Switches, Vents - Worn, Scratch, Cut, Crack - Small / Ceiling - Grime - Medium / Steering Wheel - Worn, Peel, Crack - Small</p>	<p>Remarks (L) Rear Fender, Molding - Scratch - Small / (L) Rear Door, Molding - Scratch & Dent - Medium / (L) Front Door, Molding - Scratch & Dent - Large / (L) Step, In-panel, Side Spoiler - Scratch & Dent - Medium / (L) Front Fender, Molding - Scratch - Minimal / Front Bumper, Grille, Lamps - Scratch - Medium / Bonnet, Headlight - Scratch - Medium / (R) Front Fender, Molding - Scratch & Dent - Small / (R) Mirror - Scratch - Medium / (R) Front Door, Molding - Scratch - Medium / (R) Rear Door, Molding - Scratch & Dent - Medium / (R) Step, In-panel, Side Spoiler - Scratch & Dent - Medium / (R) Rear Fender, Molding - Scratch - Medium / Trunk Hood, Rear Gate - Scratch - Small / Rear Bumper, Lamps, Panels - Scratch - Medium / Roof - Scratch - Medium</p>
