## General Information

<b>Make</b>	Toyota	<b>Model</b>	Wigo
<b>YOM</b>	2022	<b>Odo Meter Reading</b>	12,114
<b>Registration No.</b>	DAQ4998	<b>Chassis No.</b>	MHKA4DF5FNJ068386
<b>CC</b>	1.0	<b>Transmission</b>	A/T
<b>Fuel Type</b>	Gas	<b>Type of Body</b>	Hatchback
<b>Colour</b>	Orange

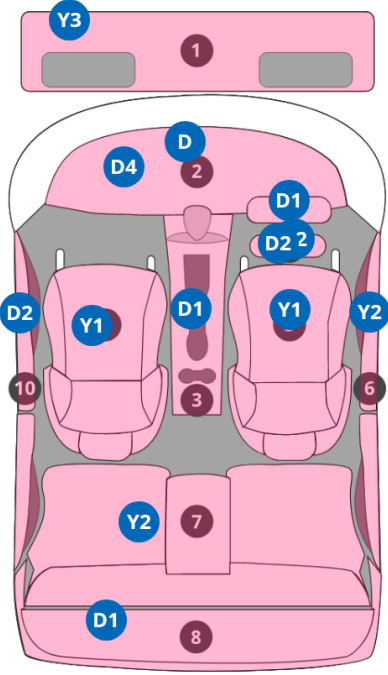
<b>Interior Evaluation :</b> <span style="float: right; color: red; font-weight: bold;">C</span>	<b>Exterior Evaluation :</b> <span style="float: right; color: red; font-weight: bold;">E</span>

<p><b>a</b> : Cut, Fray <b>d</b> : Loose, Deformed <b>k</b> : Animal Hair <b>s</b> : Smell <b>t</b> : Cigarette Burns <b>x</b> : Defective <b>y</b> : Stain</p>

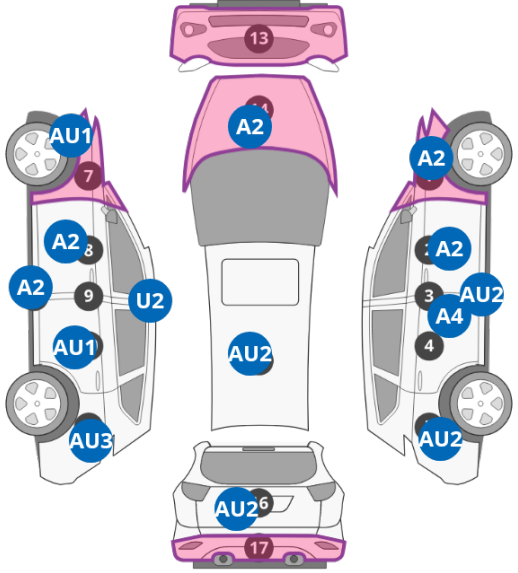
<p><b>A</b> : Scratch <b>AU</b> : Scratch &amp; Dent <b>B</b> : Modified <b>C</b> : Corrosion <b>G</b> : Stone chip <b>P</b> : Faded <b>S</b> : Rust <b>SC</b> : Rust &amp; Corrosion <b>U</b> : Dent <b>X</b> : Defective <b>Y</b> : Crack, Gap</p>
<p><b>Remarks</b> Ceiling - Grime - Medium / Dashboard - Traces of Adhesive Tape - Yes / Dashboard - Worked - Large / Glove Box - Worked - Minimal / (R) Front Floor Mat - Worked - Small / (L) Front Floor Mat - Worked - Small / (L) Front Trim - Worked - Small / (R) Rear Trim - Grime - Small / (L) Front Seat - Grime - Minimal / (R) Front Seat - Grime - Minimal / Console, Switches, Vents - Worked - Minimal / Rear Seat - Grime - Small / Trunk Room - Worked - Minimal</p>	<p><b>Remarks</b> (R) Front Fender - Repair Traces - Yes / Bonnet - Repair Traces - Yes / (L) Front Fender - Repair Traces - Yes / (L) Front Door - Repair Traces - Yes / (R) Front Fender, Molding - Repair mark - Yes / (L) Front Fender, Molding - Scratch &amp; Dent - Minimal / Front Bumper, Grille, Lamps - Repair mark - Difference in Color / (L) Front Fender, Molding - Repair mark - Yes / Roof - Scratch &amp; Dent - Small / (L) Rear Door, Molding - Scratch &amp; Dent - Minimal / (L) Front Door, Molding - Scratch - Small / (L) Step, In-panel, Side Spoiler - Scratch - Small / (L) Rear Fender, Molding - Scratch &amp; Dent - Medium / Rear Bumper, Lamps, Panels - Repair mark - Difference in Color / Trunk Hood, Rear Gate - Scratch &amp; Dent - Small / (R) Rear Door, Molding - Scratch - Large / (R) Step, In-panel, Side Spoiler - Scratch &amp; Dent - Small / (R) Front Door, Molding - Scratch - Small / (R) Front Fender, Molding - Scratch - Small / Bonnet, Headlight - Scratch - Small / (R) Rear Fender, Molding - Scratch &amp; Dent - Small / (L) Center Panel - Dent - Small / Bonnet, Headlight - Repair mark - Yes</p>
