## General Information

<b>Make</b>	Toyota	<b>Model</b>	Vios
<b>YOM</b>	2025	<b>Odo Meter Reading</b>	11,801
<b>Registration No.</b>	DBQ4524	<b>Chassis No.</b>	PA1B18F34R4268937
<b>CC</b>	1.3	<b>Transmission</b>	CVT
<b>Fuel Type</b>	Gas	<b>Type of Body</b>	Sedan
<b>Colour</b>	Blue

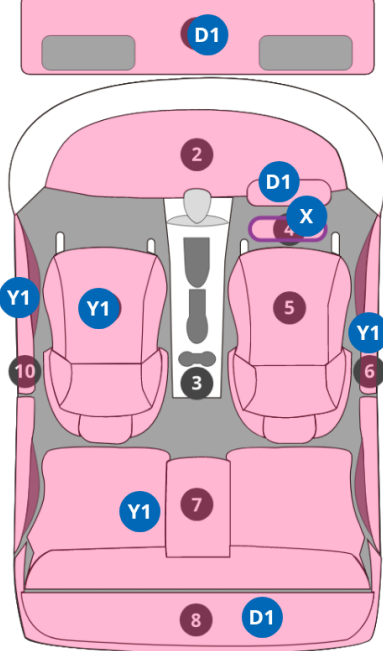
<b>Interior Evaluation :</b> <span style="float: right;"><b>B</b></span>	<b>Exterior Evaluation :</b> <span style="float: right;"><b>C</b></span>

<p><b>a</b> : Cut, Fray <b>d</b> : Loose, Deformed <b>k</b> : Animal Hair <b>s</b> : Smell <b>t</b> : Cigarette Burns <b>x</b> : Defective <b>y</b> : Stain</p>

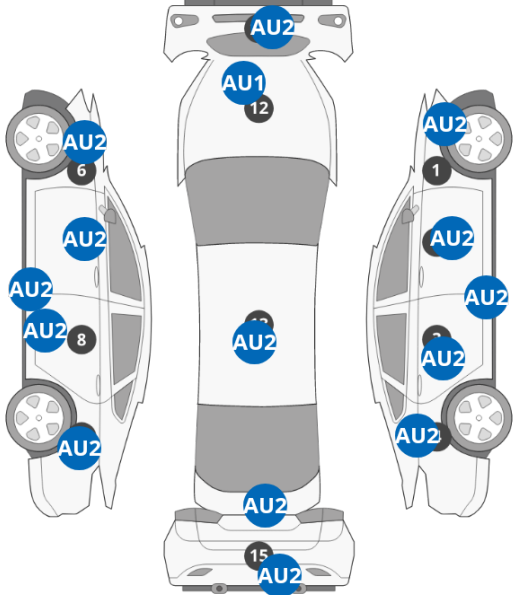
<p><b>A</b> : Scratch <b>AU</b> : Scratch &amp; Dent <b>B</b> : Modified <b>C</b> : Corrosion <b>G</b> : Stone chip <b>P</b> : Faded <b>S</b> : Rust <b>SC</b> : Rust &amp; Corrosion <b>U</b> : Dent <b>X</b> : Defective <b>Y</b> : Crack, Gap</p>
<p><b>Remarks</b> (L) Front Trim - Grime - Minimal / Mat Other - Missing - Yes / (R) Front Seat - Grime - Minimal / (L) Front Seat - Grime - Minimal / Rear Seat - Grime - Minimal / Glove Box - Worked - Minimal / Ceiling - Crinkle - Minimal / Trunk Room - Worked - Minimal / (R) Front Trim - Grime - Minimal</p>	<p><b>Remarks</b> Bonnet, Headlight - Scratch &amp; Dent - Minimal / (R) Front Fender, Molding - Scratch &amp; Dent - Small / (R) Front Door, Molding - Scratch &amp; Dent - Small / (R) Rear Door, Molding - Scratch &amp; Dent - Small / (R) Step, In-panel, Side Spoiler - Scratch &amp; Dent - Small / (R) Rear Fender, Molding - Scratch &amp; Dent - Small / Trunk Hood, Rear Gate - Scratch &amp; Dent - Small / Rear Bumper, Lamps, Panels - Scratch &amp; Dent - Small / (L) Rear Fender, Molding - Scratch &amp; Dent - Small / (L) Rear Door, Molding - Scratch &amp; Dent - Small / (L) Step, In-panel, Side Spoiler - Scratch &amp; Dent - Small / (L) Front Door, Molding - Scratch &amp; Dent - Small / Roof - Scratch &amp; Dent - Small / (L) Front Fender, Molding - Scratch &amp; Dent - Small / Front Bumper, Grille, Lamps - Scratch &amp; Dent - Small</p>
