General Information

Make	Toyota	Model	Vios
YOM	2024	Odo Meter Reading	6,961
Registration No.	DBR2736	Chassis No.	PA1B18F39R4258484
CC	1.3	Transmission	CVT
Fuel Type	Gas	Type of Body	Sedan
Colour	Silver

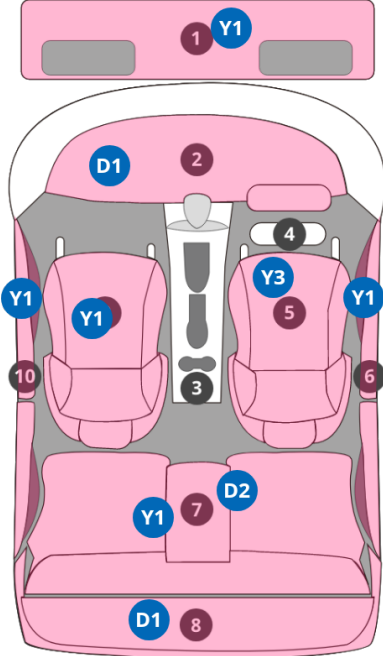
Interior Evaluation : B	Exterior Evaluation : E

<p>a : Cut, Fray d : Loose, Deformed k : Animal Hair s : Smell t : Cigarette Burns x : Defective y : Stain</p>

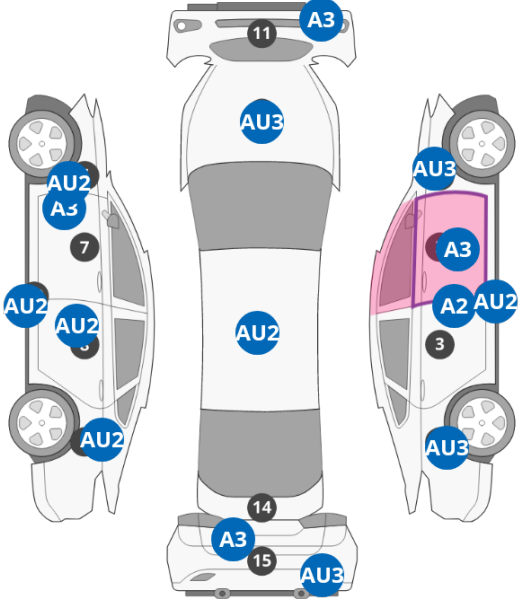
<p>A : Scratch AU : Scratch & Dent B : Modified C : Corrosion G : Stone chip P : Faded S : Rust SC : Rust & Corrosion U : Dent X : Defective Y : Crack, Gap</p>
<p>Remarks (R) Front Seat - Grime - Medium / (L) Front Seat - Grime - Minimal / Rear Seat Head Rest - Worked - Small / Rear Seat - Grime - Minimal / (L) Front Trim - Grime - Minimal / (R) Front Trim - Grime - Minimal / Ceiling - Grime - Minimal / Trunk Room - Worked - Minimal / Dashboard - Worked - Minimal</p>	<p>Remarks (R) Front Door, Molding - Repair mark - Yes / (R) Front Fender, Molding - Scratch & Dent - Medium / (R) Front Door, Molding - Scratch - Medium / (R) Rear Door, Molding - Scratch - Small / (R) Step, In-panel, Side Spoiler - Scratch & Dent - Small / (R) Rear Fender, Molding - Scratch & Dent - Medium / Rear Bumper, Lamps, Panels - Scratch & Dent - Medium / Trunk Hood, Rear Gate - Scratch - Medium / (L) Rear Fender, Molding - Scratch & Dent - Small / Roof - Scratch & Dent - Small / (L) Rear Door, Molding - Scratch & Dent - Small / (L) Step, In-panel, Side Spoiler - Scratch & Dent - Small / (L) Front Door, Molding - Scratch - Medium / (L) Front Fender, Molding - Scratch & Dent - Small / Front Bumper, Grille, Lamps - Scratch - Medium / Bonnet, Headlight - Scratch & Dent - Medium</p>
