## General Information

<b>Make</b>	Toyota	<b>Model</b>	Vios
<b>YOM</b>	2025	<b>Odo Meter Reading</b>	7,620
<b>Registration No.</b>	DBU5601	<b>Chassis No.</b>	PA1B18F37S4286273
<b>CC</b>	1.3	<b>Transmission</b>	CVT
<b>Fuel Type</b>	Gas	<b>Type of Body</b>	Sedan
<b>Colour</b>	Red

## Body / Panel Condition

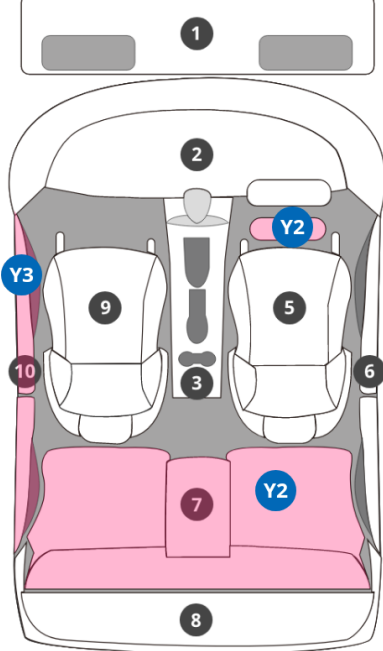
<b>Interior Evaluation :</b> <span style="float: right;"><b>B</b></span>	<b>Exterior Evaluation :</b> <span style="float: right;"><b>A</b></span>

<p><b>a</b> : Cut, Fray <b>d</b> : Loose, Deformed <b>k</b> : Animal Hair <b>s</b> : Smell <b>t</b> : Cigarette Burns <b>x</b> : Defective <b>y</b> : Stain</p>

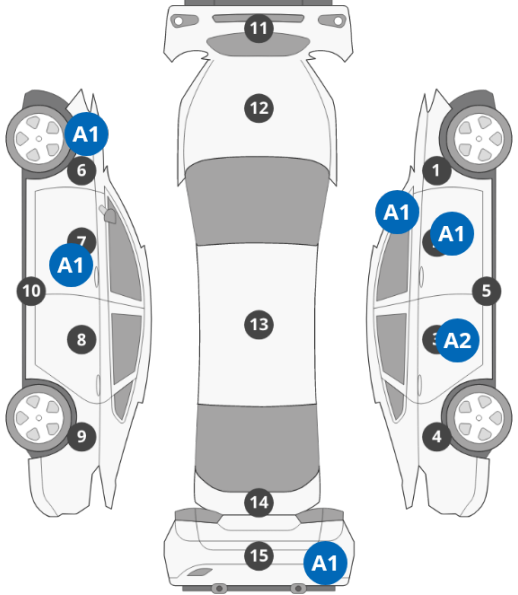
<p><b>A</b> : Scratch <b>AU</b> : Scratch &amp; Dent <b>B</b> : Modified <b>C</b> : Corrosion <b>G</b> : Stone chip <b>P</b> : Faded <b>S</b> : Rust <b>SC</b> : Rust &amp; Corrosion <b>U</b> : Dent <b>X</b> : Defective <b>Y</b> : Crack, Gap</p>
<p><b>Remarks</b> Rear Seat - Grime - Small / (L) Front Trim - Grime - Medium / (L) Front Floor Mat - Grime - Small</p>	<p><b>Remarks</b> (L) Front Door, Molding - Scratch - Minimal / (L) Front Fender, Molding - Scratch - Minimal / (R) Mirror - Scratch - Minimal / (R) Front Door, Molding - Scratch - Minimal / (R) Rear Door, Molding - Scratch - Small / Rear Bumper, Lamps, Panels - Scratch - Minimal</p>
