## General Information

| <b>Make</b> | Toyota | <b>Model</b> | Vios |

## Body / Panel Condition

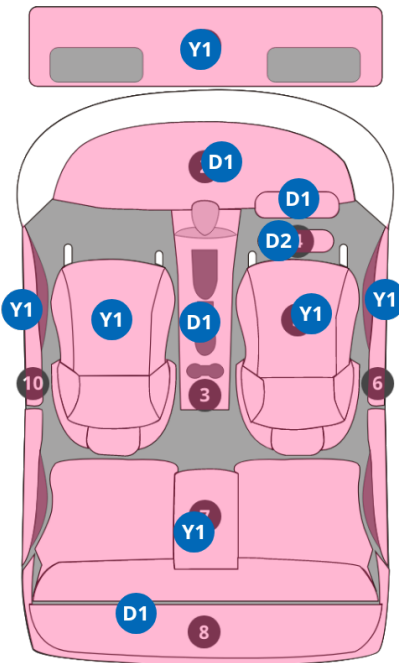
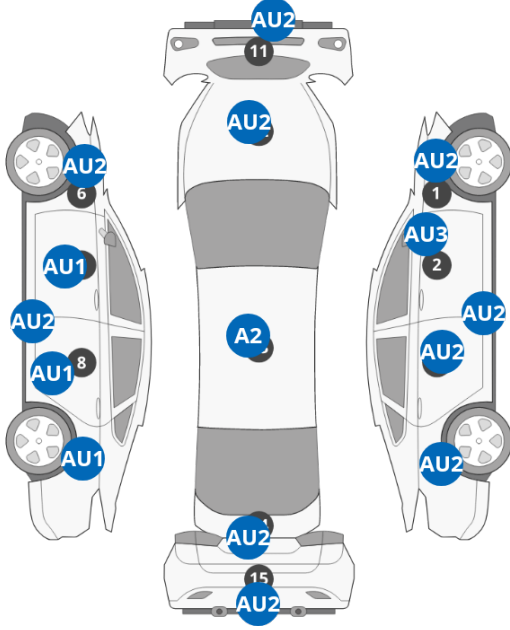
| <b>Interior Evaluation :</b> <span style="float: right;"><b>B</b></span> | <b>Exterior Evaluation :</b> <span style="float: right;"><b>C</b></span> |
| <p><b>a</b> : Cut, Fray <b>d</b> : Loose, Deformed <b>k</b> : Animal Hair <b>s</b> : Smell <b>t</b> : Cigarette Burns <b>x</b> : Defective <b>y</b> : Stain</p> | <p><b>A</b> : Scratch <b>AU</b> : Scratch &amp; Dent <b>B</b> : Modified <b>C</b> : Corrosion <b>G</b> : Stone chip <b>P</b> : Faded <b>S</b> : Rust <b>SC</b> : Rust &amp; Corrosion <b>U</b> : Dent <b>X</b> : Defective <b>Y</b> : Crack, Gap</p> |
| <p><b>Remarks</b><br/>(L) Front Trim - Grime - Minimal / (R) Front Trim - Grime - Minimal / (L) Front Floor Mat - Worked - Small / (L) Front Seat - Grime - Minimal / (R) Front Seat - Grime - Minimal / Rear Seat - Grime - Minimal / Trunk Room - Worked - Minimal / Ceiling - Grime - Minimal / Dashboard - Worked - Minimal / Console, Switches, Vents - Worked - Minimal / Glove Box - Worked - Minimal</p> | <p><b>Remarks</b><br/>Trunk Hood, Rear Gate - Scratch &amp; Dent - Small / (L) Rear Fender, Molding - Scratch &amp; Dent - Minimal / (L) Rear Door, Molding - Scratch &amp; Dent - Minimal / (L) Step, In-panel, Side Spoiler - Scratch &amp; Dent - Small / (L) Front Door, Molding - Scratch &amp; Dent - Minimal / (L) Front Fender, Molding - Scratch &amp; Dent - Small / Bonnet, Headlight - Scratch &amp; Dent - Small / Front Bumper, Grille, Lamps - Scratch &amp; Dent - Small / (R) Front Fender, Molding - Scratch &amp; Dent - Small / (R) Front Door, Molding - Scratch &amp; Dent - Medium / (R) Rear Door, Molding - Scratch &amp; Dent - Small / (R) Step, In-panel, Side Spoiler - Scratch &amp; Dent - Small / (R) Rear Fender, Molding - Scratch &amp; Dent - Small / Rear Bumper, Lamps, Panels - Scratch &amp; Dent - Small / Roof - Scratch - Small</p> |
