General Information

Make	Toyota	Model	Vios
YOM	2025	Odo Meter Reading	22,378
Registration No.	NEY9670	Chassis No.	PA1B18F39R4262602
CC	1.3	Transmission	CVT
Fuel Type	Gas	Type of Body	Sedan
Colour	Red Mica Metallic

Body / Panel Condition

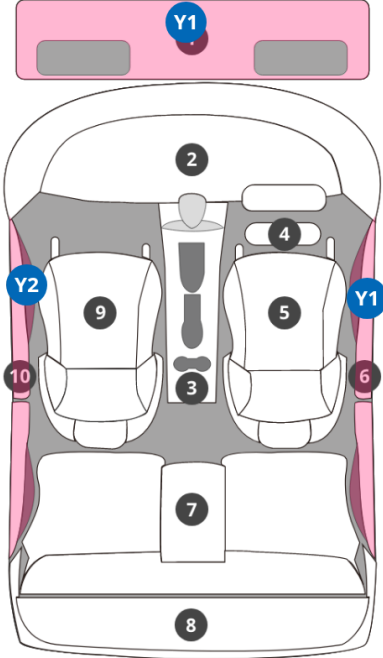
Interior Evaluation : A	Exterior Evaluation : C

<p>a : Cut, Fray d : Loose, Deformed k : Animal Hair s : Smell t : Cigarette Burns x : Defective y : Stain</p>

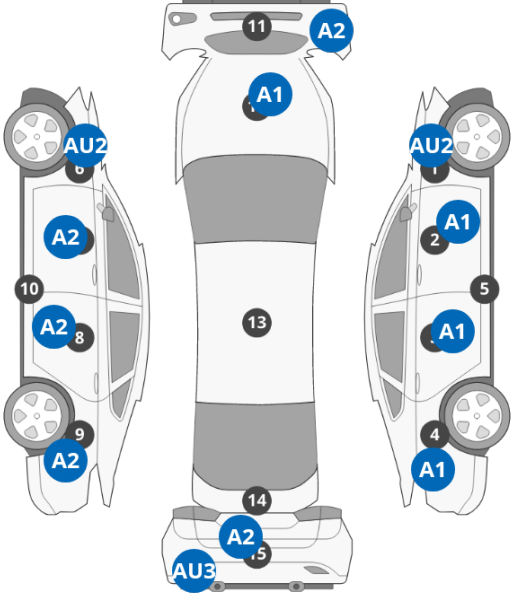
<p>A : Scratch AU : Scratch & Dent B : Modified C : Corrosion G : Stone chip P : Faded S : Rust SC : Rust & Corrosion U : Dent X : Defective Y : Crack, Gap</p>
<p>Remarks (R) Front Trim - Grime - Minimal / (L) Front Trim - Grime - Small / Ceiling - Grime - Minimal</p>	<p>Remarks Rear Bumper, Lamps, Panels - Scratch & Dent - Medium / Trunk Hood, Rear Gate - Scratch - Small / (L) Rear Fender, Molding - Scratch - Small / (L) Rear Door, Molding - Scratch - Small / (L) Front Door, Molding - Scratch - Small / (L) Front Fender, Molding - Scratch & Dent - Small / Front Bumper, Grille, Lamps - Scratch - Small / Bonnet, Headlight - Scratch - Minimal / (R) Front Fender, Molding - Scratch & Dent - Small / (R) Front Door, Molding - Scratch - Minimal / (R) Rear Door, Molding - Scratch - Minimal / (R) Rear Fender, Molding - Scratch - Minimal</p>
