General Information

Make	Toyota	Model	Avanza
YOM	2023	Odo Meter Reading	130,532
Registration No.	NHB6354	Chassis No.	MHFAA1BY4N0006678
CC	1.3	Transmission	CVT
Fuel Type	Gas	Type of Body	MPV
Colour	Silver

Body / Panel Condition

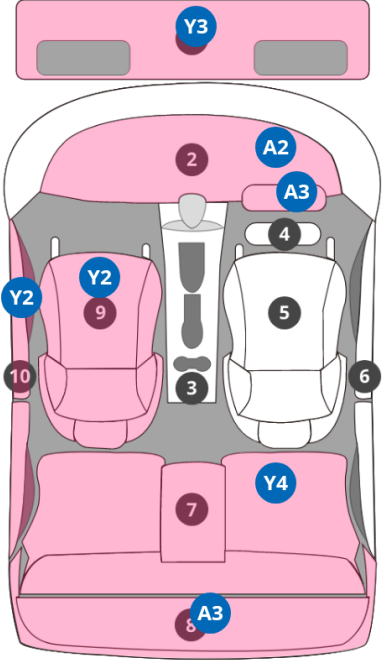
Interior Evaluation : C	Exterior Evaluation : D

<p>a : Cut, Fray d : Loose, Deformed k : Animal Hair s : Smell t : Cigarette Burns x : Defective y : Stain</p>

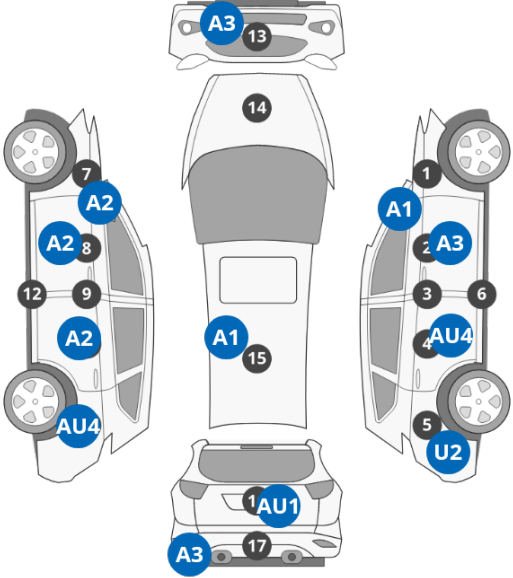
<p>A : Scratch AU : Scratch & Dent B : Modified C : Corrosion G : Stone chip P : Faded S : Rust SC : Rust & Corrosion U : Dent X : Defective Y : Crack, Gap</p>
<p>Remarks Rear Seat - Grime - Large / Dashboard - Worn, Scratch, Cut, Crack - Small / Trunk Room - Worn, Scratch, Cut, Crack - Medium / (L) Front Seat - Grime - Small / (L) Front Trim - Grime - Small / Steering Wheel - Worn, Peel, Crack - Medium / Ceiling - Grime - Medium</p>	<p>Remarks (R) Rear Fender, Molding - Dent - Small / Rear Bumper, Lamps, Panels - Scratch - Medium / (L) Rear Fender, Molding - Scratch & Dent - Large / (L) Rear Door, Molding - Scratch - Small / (L) Front Door, Molding - Scratch - Small / (L) Mirror - Scratch - Small / Front Bumper, Grille, Lamps - Scratch - Medium / (R) Mirror - Scratch - Minimal / (R) Front Door, Molding - Scratch - Medium / (R) Rear Door, Molding - Scratch & Dent - Large / Trunk Hood, Rear Gate - Scratch & Dent - Minimal / Roof - Scratch - Minimal</p>
