General Information

Make	Toyota	Model	Vios
YOM	2024	Odo Meter Reading	8,572
Registration No.	NHM4709	Chassis No.	PA1B18F31R4243414
CC	1.3	Transmission	CVT
Fuel Type	Gas	Type of Body	Sedan
Colour	Red Mica Metallic

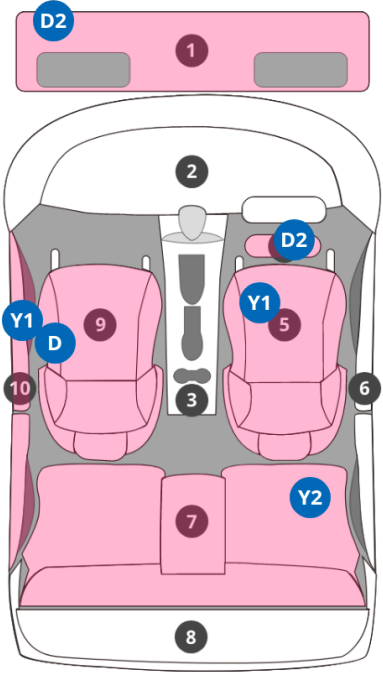
Interior Evaluation : B	Exterior Evaluation : C

<p>a : Cut, Fray d : Loose, Deformed k : Animal Hair s : Smell t : Cigarette Burns x : Defective y : Stain</p>

<p>A : Scratch AU : Scratch & Dent B : Modified C : Corrosion G : Stone chip P : Faded S : Rust SC : Rust & Corrosion U : Dent X : Defective Y : Crack, Gap</p>
<p>Remarks (L) Front Seat - Worn - Yes / (L) Front Trim - Grime - Minimal / Ceiling - Crinkle - Small / (R) Front Seat - Grime - Minimal / (L) Front Floor Mat - Worked - Small / Rear Seat - Grime - Small</p>	<p>Remarks (R) Mirror - Scratch - Small / (R) Front Fender, Molding - Scratch - Minimal / Roof - Scratch & Dent - Small / (R) Front Door, Molding - Scratch - Medium / (R) Step, In-panel, Side Spoiler - Scratch - Small / (R) Rear Door, Molding - Scratch - Small / (R) Rear Fender, Molding - Scratch - Small / Rear Bumper, Lamps, Panels - Scratch - Small / Trunk Hood, Rear Gate - Scratch - Small / (L) Rear Fender, Molding - Dent - Small / (L) Rear Door, Molding - Scratch - Small / (L) Front Door, Molding - Scratch - Minimal / (L) Mirror - Scratch - Minimal / (L) Front Fender, Molding - Scratch - Minimal / Front Bumper, Grille, Lamps - Scratch - Small / Bonnet, Headlight - Scratch - Small</p>

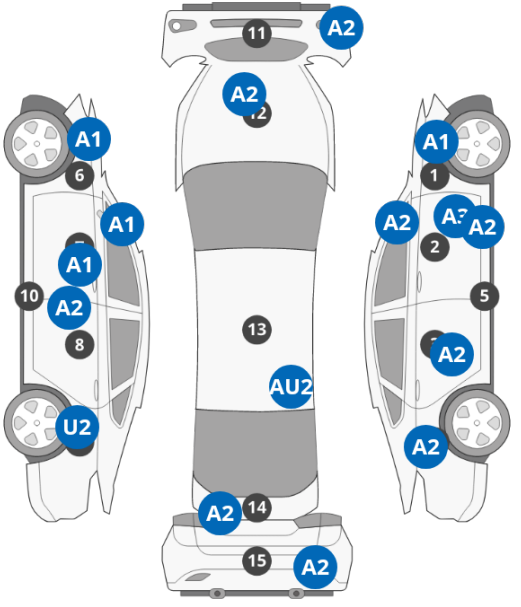
<p>Inspector Notes</p>
<p>no warranty booklet, with jack, no tools, with spare tire, with LTO plate, scratches on tail light</p>
