General Information

Make	Toyota	Model	Vios
YOM	2024	Odo Meter Reading	16,954
Registration No.	NHR9001	Chassis No.	PA1B18F35P4228993
CC	1.3	Transmission	CVT
Fuel Type	Gas	Type of Body	Sedan
Colour	Green

Body / Panel Condition

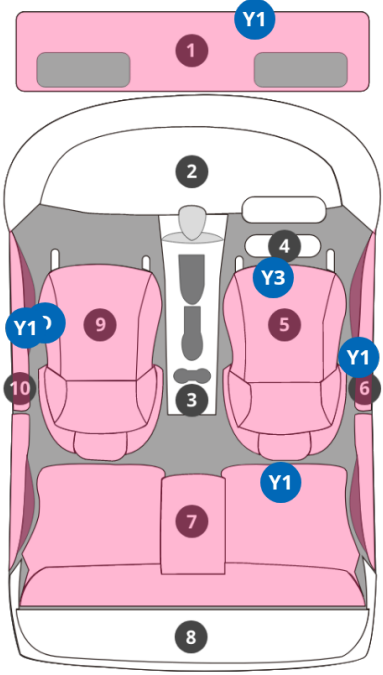
<p>a : Cut, Fray d : Loose, Deformed k : Animal Hair s : Smell t : Cigarette Burns x : Defective y : Stain</p>

<p>A : Scratch AU : Scratch & Dent B : Modified C : Corrosion G : Stone chip P : Faded S : Rust SC : Rust & Corrosion U : Dent X : Defective Y : Crack, Gap</p>
<p>Remarks (L) Front Seat - Worn - Yes / (R) Front Seat - Grime - Medium / Rear Seat - Grime - Minimal / (R) Front Trim - Grime - Minimal / (L) Front Trim - Grime - Minimal / Ceiling - Grime - Minimal</p>	<p>Remarks (R) Mirror - Scratch - Minimal / (R) Front Fender, Molding - Scratch - Minimal / (R) Rear Door, Molding - Scratch - Small / (R) Front Door, Molding - Scratch - Minimal / (R) Rear Fender, Molding - Dent - Small / Rear Bumper, Lamps, Panels - Scratch - Small / Trunk Hood, Rear Gate - Scratch - Minimal / (L) Rear Door, Molding - Scratch & Dent - Small / (L) Rear Fender, Molding - Scratch - Minimal / (L) Front Door, Molding - Scratch & Dent - Small / (L) Front Fender, Molding - Scratch - Small / (L) Mirror - Scratch - Minimal / Front Bumper, Grille, Lamps - Scratch - Medium / Bonnet, Headlight - Scratch - Minimal / Roof - Scratch - Minimal</p>
