General Information

Make	Toyota	Model	Vios
YOM	2025	Odo Meter Reading	14,132
Registration No.	NJF4757	Chassis No.	PA1B18F33S4282544
CC	1.3	Transmission	CVT
Fuel Type	Gas	Type of Body	Sedan
Colour	Blue

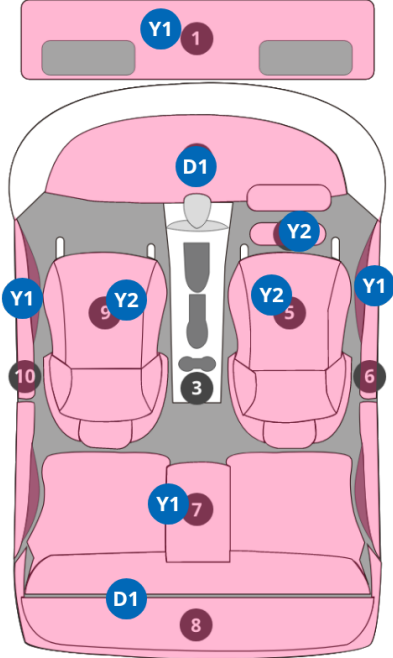
Interior Evaluation : B	Exterior Evaluation : C

<p>a : Cut, Fray d : Loose, Deformed k : Animal Hair s : Smell t : Cigarette Burns x : Defective y : Stain</p>

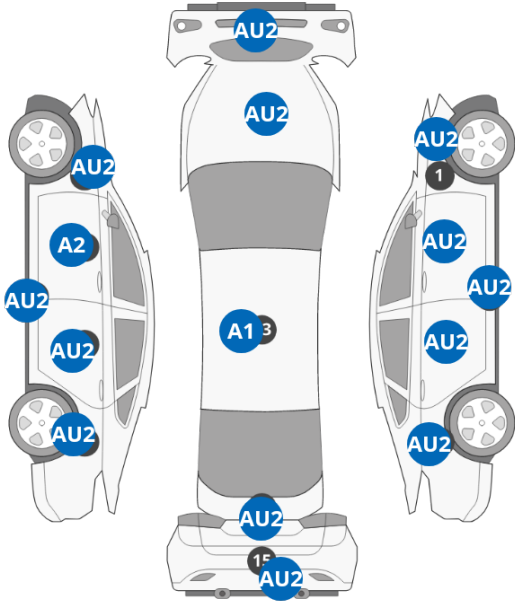
<p>A : Scratch AU : Scratch & Dent B : Modified C : Corrosion G : Stone chip P : Faded S : Rust SC : Rust & Corrosion U : Dent X : Defective Y : Crack, Gap</p>
Remarks (L) Front Floor Mat - Grime - Small / (L) Front Seat - Grime - Small / (R) Front Seat - Grime - Small / Rear Seat - Grime - Minimal / (R) Front Trim - Grime - Minimal / (L) Front Trim - Grime - Minimal / Dashboard - Worked - Minimal / Ceiling - Grime - Minimal / Trunk Room - Worked - Minimal	Remarks (R) Rear Door - Repair Traces - Yes / Roof - Scratch - Minimal / (L) Rear Door, Molding - Scratch & Dent - Small / (L) Front Door, Molding - Scratch - Small / (L) Step, In-panel, Side Spoiler - Scratch & Dent - Small / (L) Front Fender, Molding - Scratch & Dent - Small / Bonnet, Headlight - Scratch & Dent - Small / (R) Front Fender, Molding - Scratch & Dent - Small / Front Bumper, Grille, Lamps - Scratch & Dent - Small / (R) Front Door, Molding - Scratch & Dent - Small / (R) Step, In-panel, Side Spoiler - Scratch & Dent - Small / (R) Rear Door, Molding - Scratch & Dent - Small / (R) Rear Fender, Molding - Scratch & Dent - Small / Trunk Hood, Rear Gate - Scratch & Dent - Small / Rear Bumper, Lamps, Panels - Scratch & Dent - Small / (L) Rear Fender, Molding - Scratch & Dent - Small
