General Information

Make	Toyota	Model	Vios
YOM	2025	Odo Meter Reading	22,890
Registration No.	NKG3599	Chassis No.	PA1B18F31R4275019
CC	1.3	Transmission	CVT
Fuel Type	Gas	Type of Body	Sedan
Colour	Blue

Body / Panel Condition

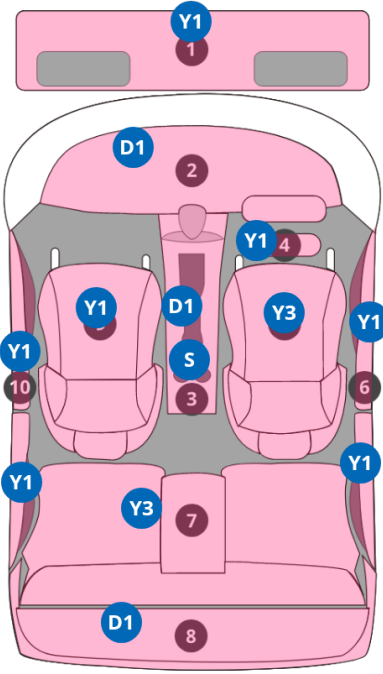
Interior Evaluation : B	Exterior Evaluation : C

<p>a : Cut, Fray d : Loose, Deformed k : Animal Hair s : Smell t : Cigarette Burns x : Defective y : Stain</p>

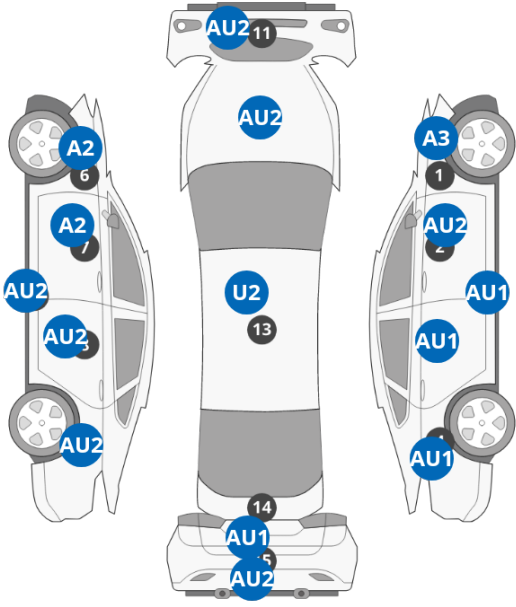
<p>A : Scratch AU : Scratch & Dent B : Modified C : Corrosion G : Stone chip P : Faded S : Rust SC : Rust & Corrosion U : Dent X : Defective Y : Crack, Gap</p>
<p>Remarks Ceiling - Grime - Minimal / Rear Seat - Grime - Medium / (R) Front Seat - Grime - Medium / (L) Front Seat - Grime - Minimal / Console, Switches, Vents - Worked - Minimal / (L) Front Floor Mat - Grime - Minimal / Overall Interior - Smell - Yes / Trunk Room - Worked - Minimal / Dashboard - Worked - Minimal / (L) Front Trim - Grime - Minimal / (R) Front Trim - Grime - Minimal / (L) Rear Trim - Grime - Minimal / (R) Rear Trim - Grime - Minimal</p>	<p>Remarks Front Bumper, Grille, Lamps - Scratch & Dent - Small / Roof - Dent - Small / (L) Front Fender, Molding - Scratch - Small / (L) Front Door, Molding - Scratch - Small / (L) Step, In-panel, Side Spoiler - Scratch & Dent - Small / (L) Rear Door, Molding - Scratch & Dent - Small / (L) Rear Fender, Molding - Scratch & Dent - Small / Rear Bumper, Lamps, Panels - Scratch & Dent - Small / Trunk Hood, Rear Gate - Scratch & Dent - Minimal / (R) Rear Fender, Molding - Scratch & Dent - Minimal / (R) Step, In-panel, Side Spoiler - Scratch & Dent - Minimal / (R) Front Fender, Molding - Scratch - Medium / (R) Front Door, Molding - Scratch & Dent - Small / (R) Rear Door, Molding - Scratch & Dent - Minimal / Bonnet, Headlight - Scratch & Dent - Small</p>
